Inventory Survey and Mapping of  
White House Trail, Tunnel Trail, and Twin Trail (West Segment)  
in Canyon de Chelly National Monument

Contract No. H1200-09-0005

May 30, 2011

FINAL

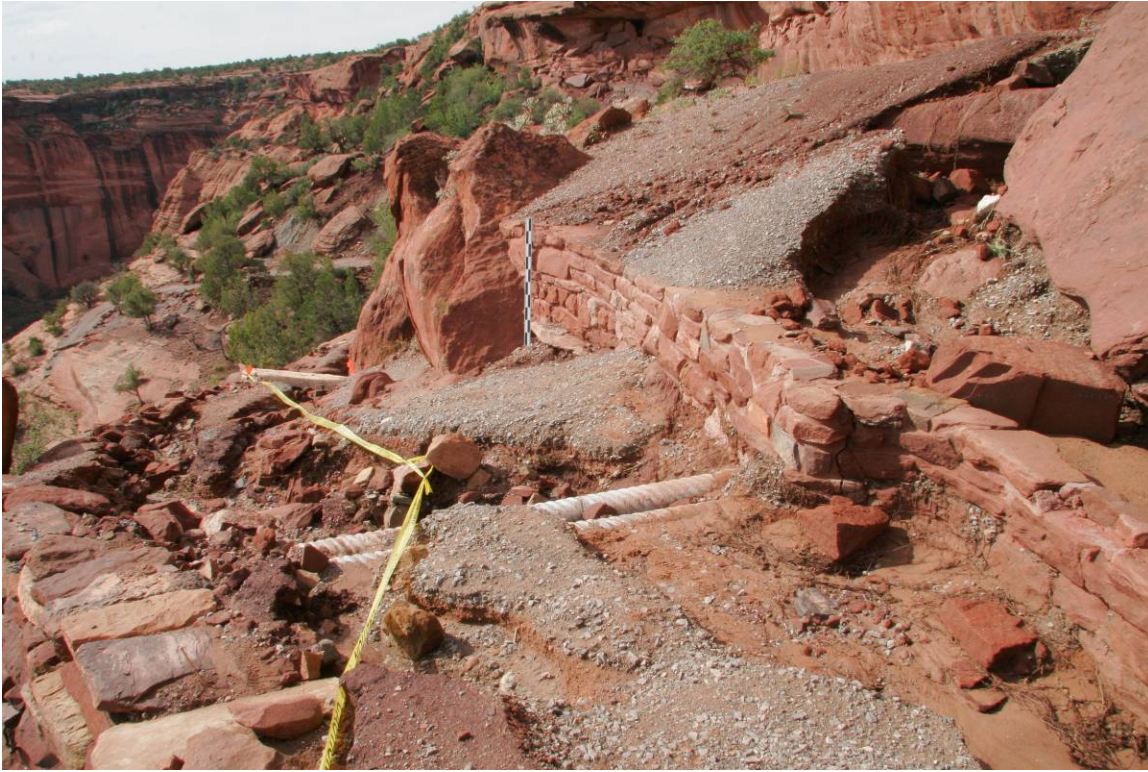
In 2007, a strong monsoon storm caused extensive damage to the upper section of White House Trail. Numerous retaining walls, drains, and other features were heavily damaged and several sections of trail tread were washed out (Figure 3). CACH archaeologists moved quickly to document the original trail features prior to reconstruction efforts. The project expanded to include documentation of features along the entire length of the trail. CACH crews returned after trail reconstruction was complete, and compiled a list of New Features that were placed to rehabilitate the trail (Figure 4). The list and map of original and new features produced by CACH crews formed the basis for the MNA feature lists for this trail (Tables 1 and 2); comments about each feature in Table 1 reflect those of the CACH crew in 2007, supplemented by additional information based on MNA's fieldwork in 2010.

Figure 3. Upper White House Trail showing extensive damage from a rainstorm in 2007.

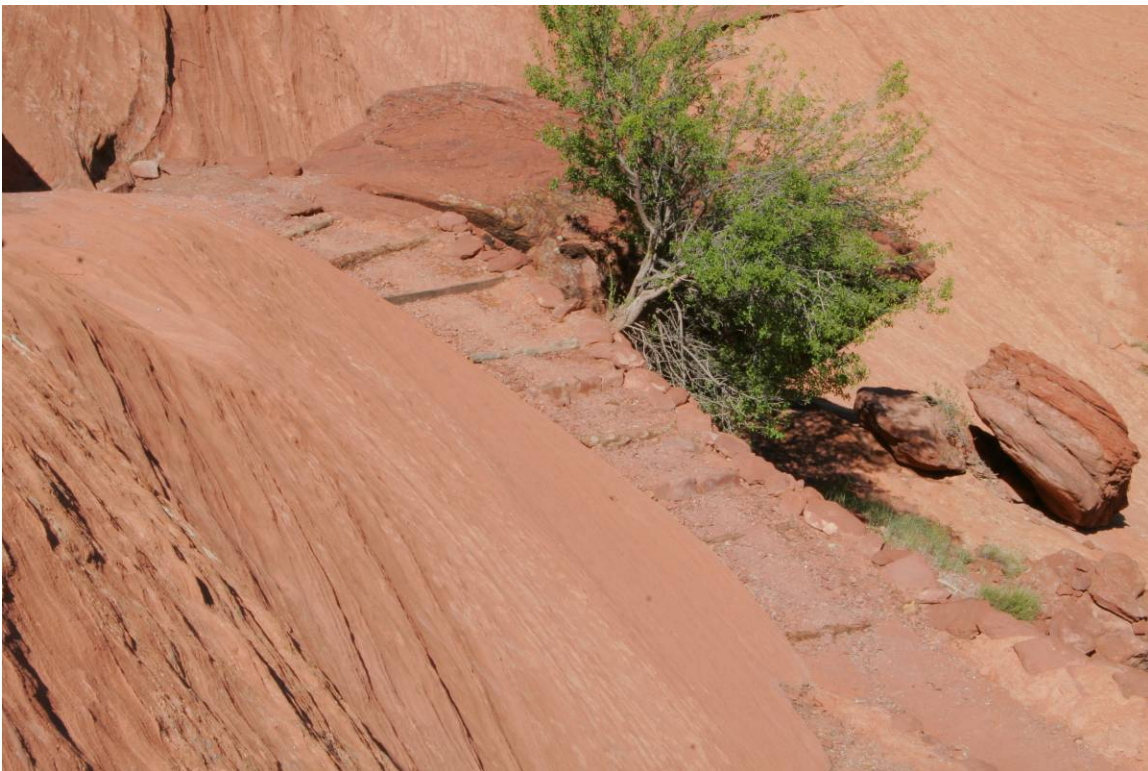
The majority of the New Features (n = 45) are retainer bars made of juniper logs and stone; most of these were installed in 2007 (see Figure 4). Other New Features include 2 trail curbs, 3 drains, 13 steps (which also serve as retainer bars), 2 borrow pits that also serve as water retention areas, and 5 alignments of reinforcing posts set along the Canyon de Chelly wash to stabilize the trail and prevent erosion.

Figure 4. Series of retainer bars installed along upper White House Trail in 2007 to repair damage.

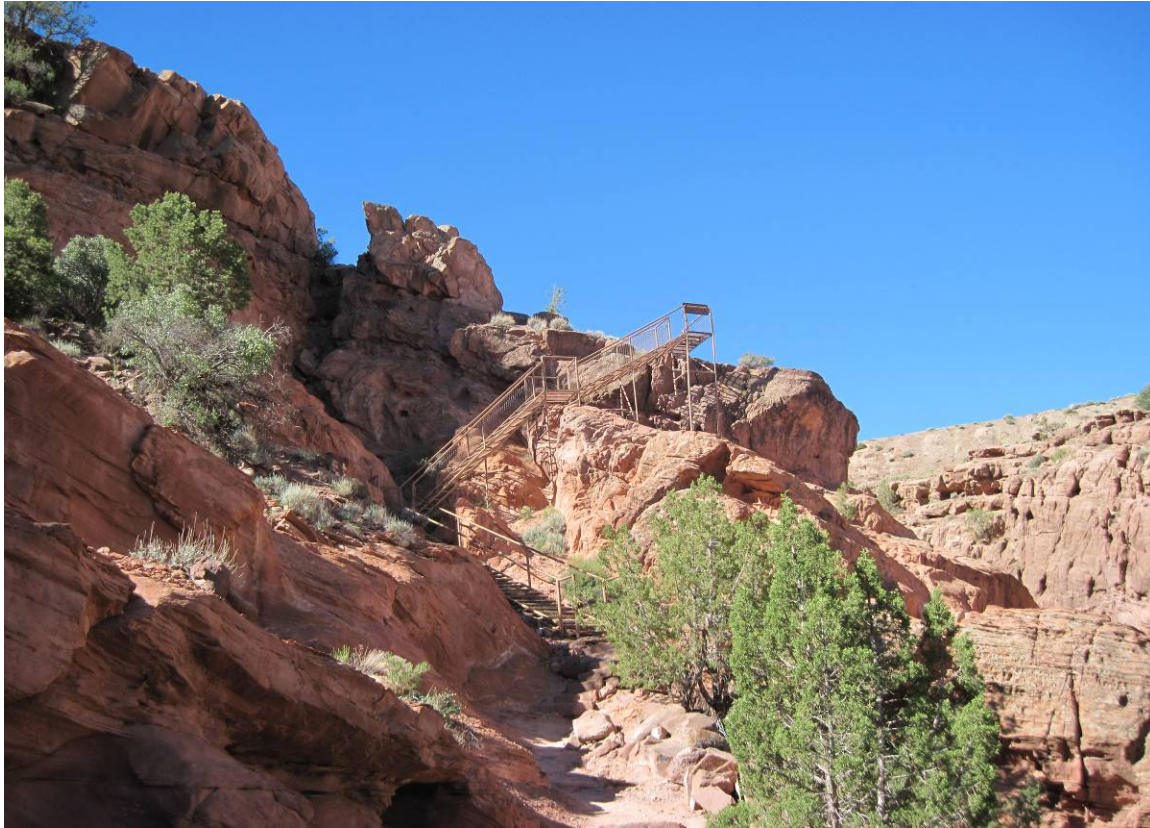
Figure 6. Metal staircase at the head of Tunnel Trail, installed about 1971.

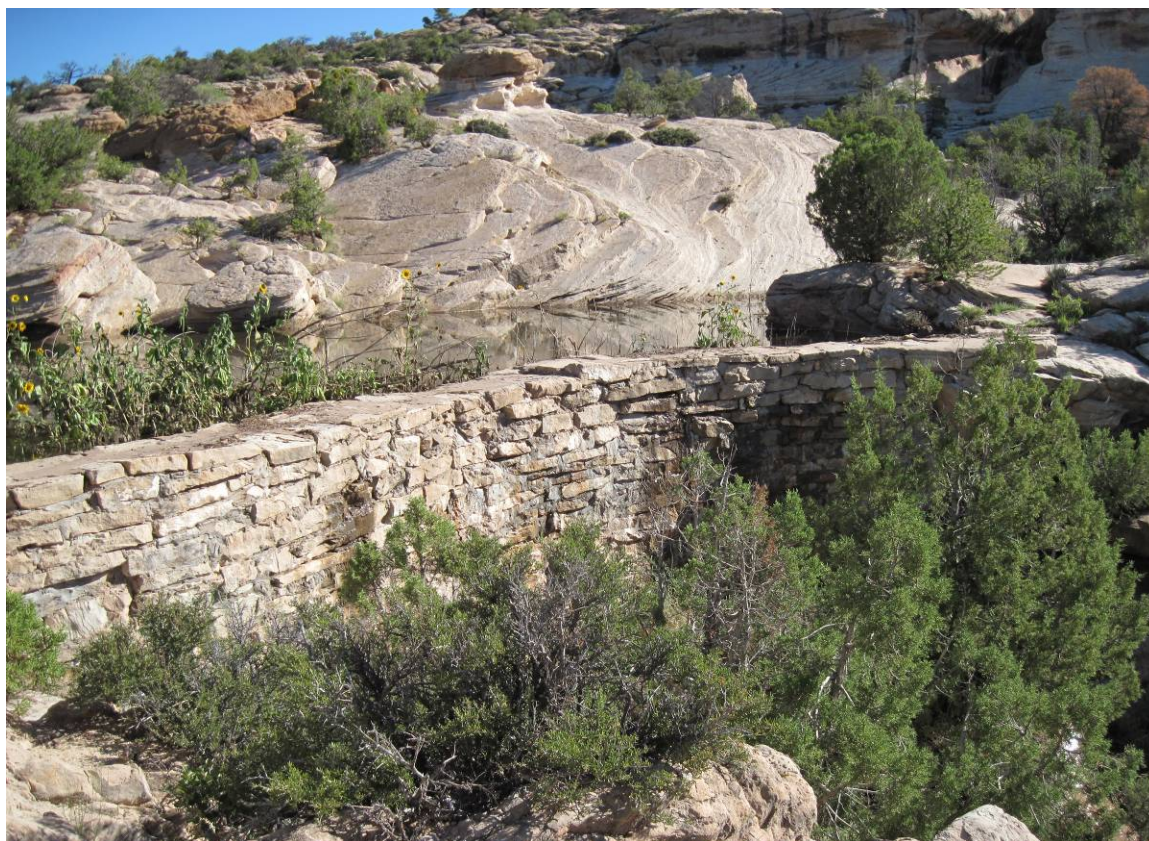
In 1963, a substantial masonry dam was built at the head of the western Twin Trail, after heavy rain and flooding destroyed an earlier erosion control feature (Brugge and Wilson 1976:199). The 1963 dam remains intact and functional (Figure 9), although its capacity has diminished due to soil buildup within the reservoir. Service crews also made improvements along Twin Trail in 1963 and 1983 (Brugge and Wilson 1976:197; Jett 1998:154).

Figure 9. Masonry dam at the head of western Twin Trail, built in 1963.

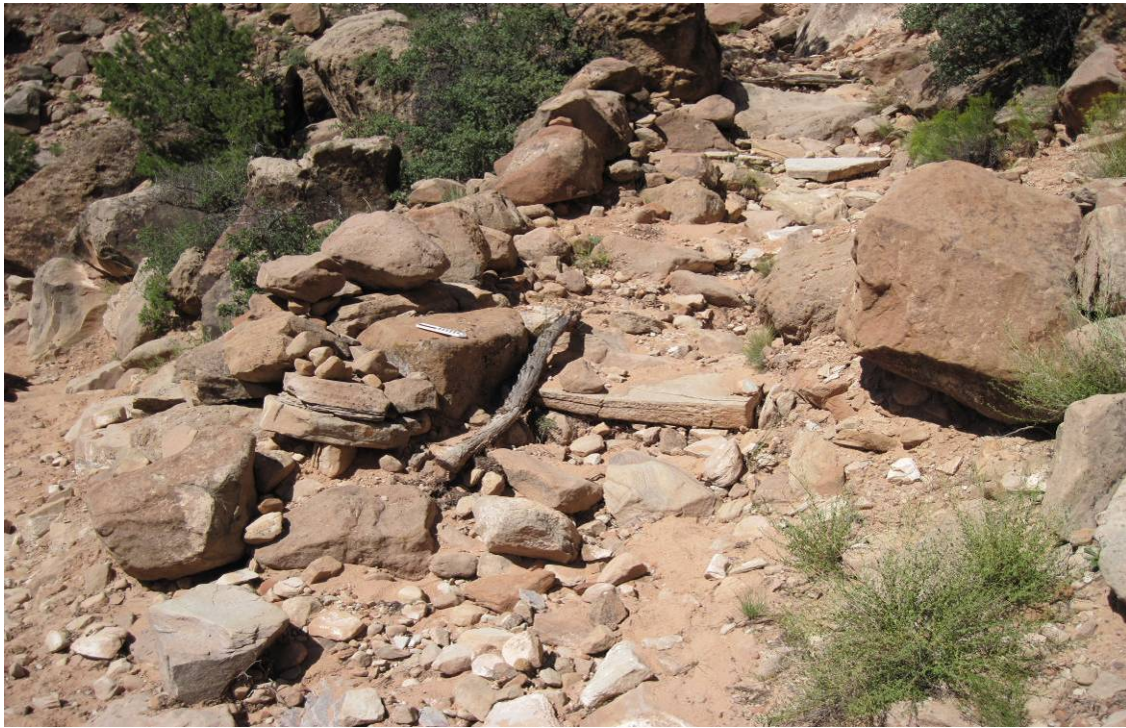
MNA's initial reconnaissance of Twin Trail occurred on June 2, at which time it was evident that this route was in the poorest condition of the three due to heavy use by local residents, natural erosion and slumping, and years of maintenance neglect. Survey of the 30 m corridor on each side of Twin Trail occurred on June 4. This effort resulted in discovery of four previously unidentified sites and nine IOs. Trail documentation took place on August 3 – 6, with final photography of features on December 1 and 2.

Figure 10. Western Twin Trail showing eroded tread, undercut steps, and generally poor condition.
