REPORT

**2005 Lower Cliff Dwelling Emergency Preservation,
Tonto National Monument**

Jeanne S. Schofer
TONT Cultural Resources Division

January 2006

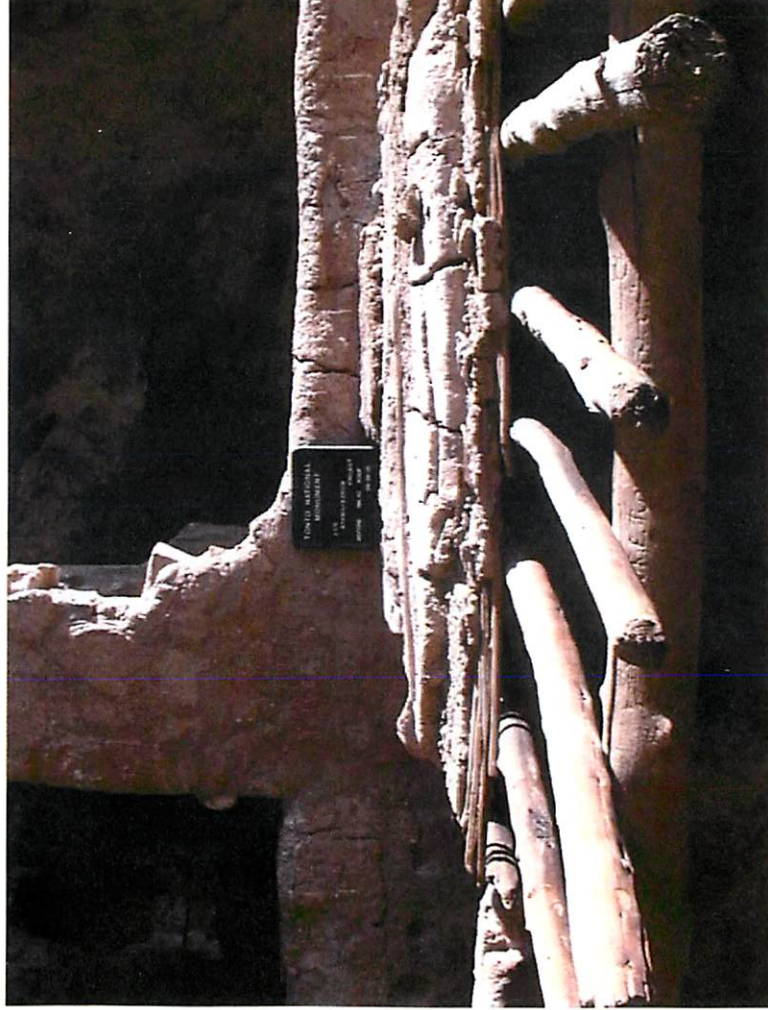
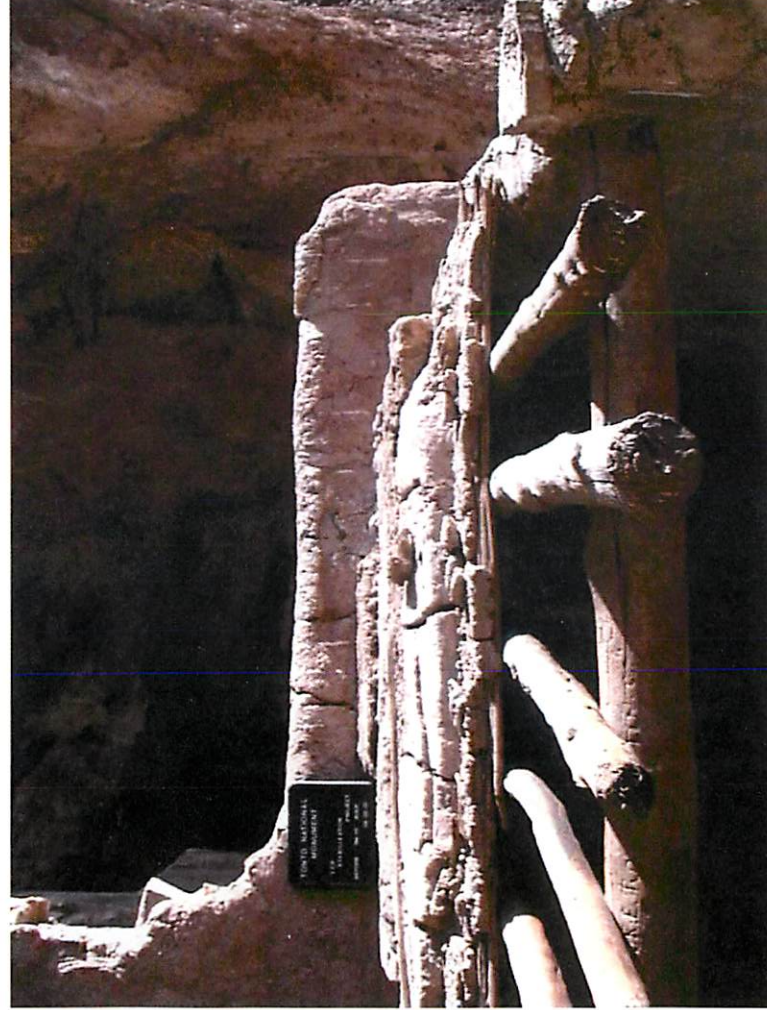
Room 10 (51.10) Roof

The roof in Room 10 has undergone deterioration from visitors picking at roof covering material (saguaro ribs and adobe).

Figure 3. Before photo of the Room 10 roof, west end.

Figure 4. Before photo of the Room 10 roof, east end.

- Room 10 Roof
This historic fabric was repaired by Duane Hubbard (TONT Archaeologist and Cultural Resources Program Manager) using 4800 mL (19 lbs) unamended, screened soil, 480 mL micro-beads, and 480 mL water. Five non-prehistoric saguaro ribs were added to the roof, all on the southern roof margin. All of the non-prehistoric elements can be identified with a wire marker that was tied to each rib. An unamended mortar was mixed with abrasive glass micro-beads and applied over the saguaro ribs on the south and west margins of the roof. Wet burlap was placed over the newly applied mix in order to reduce cracking.

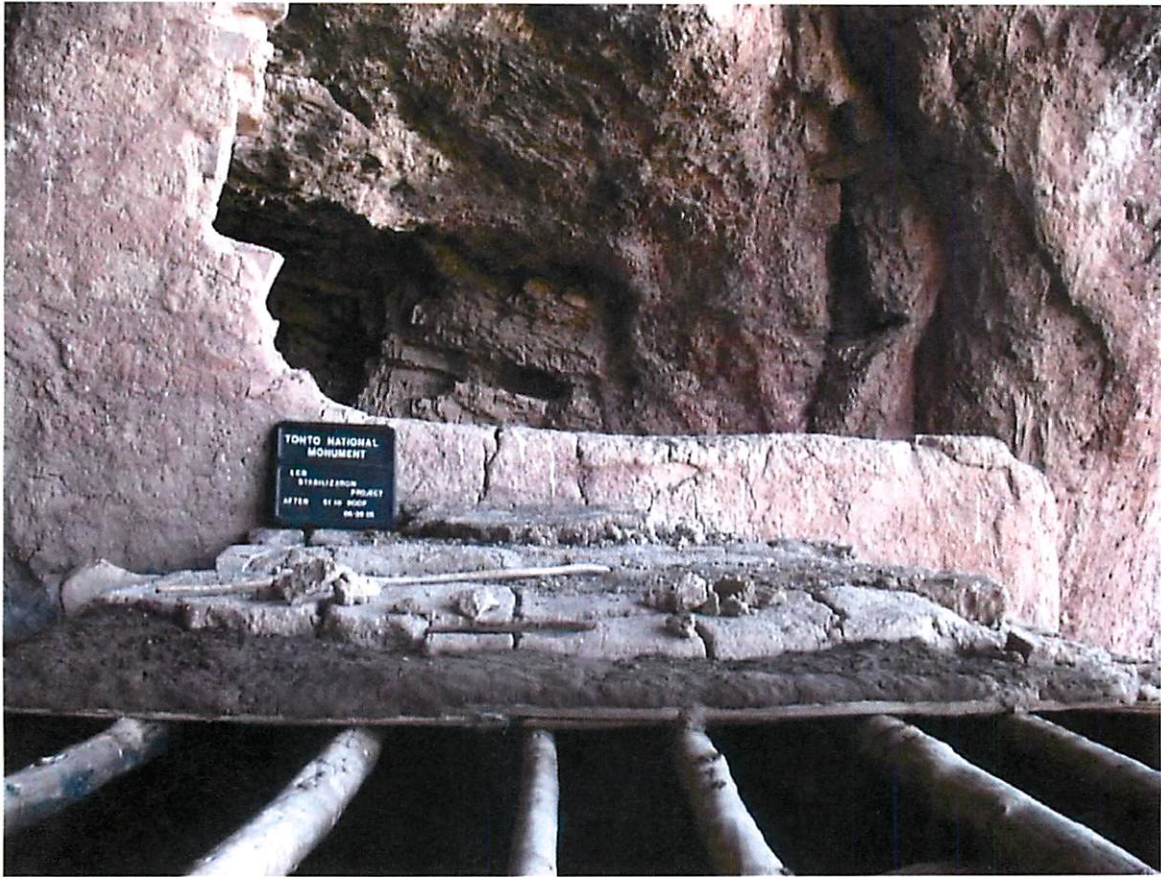
Figure 5. After photo of the Room 10 roof.

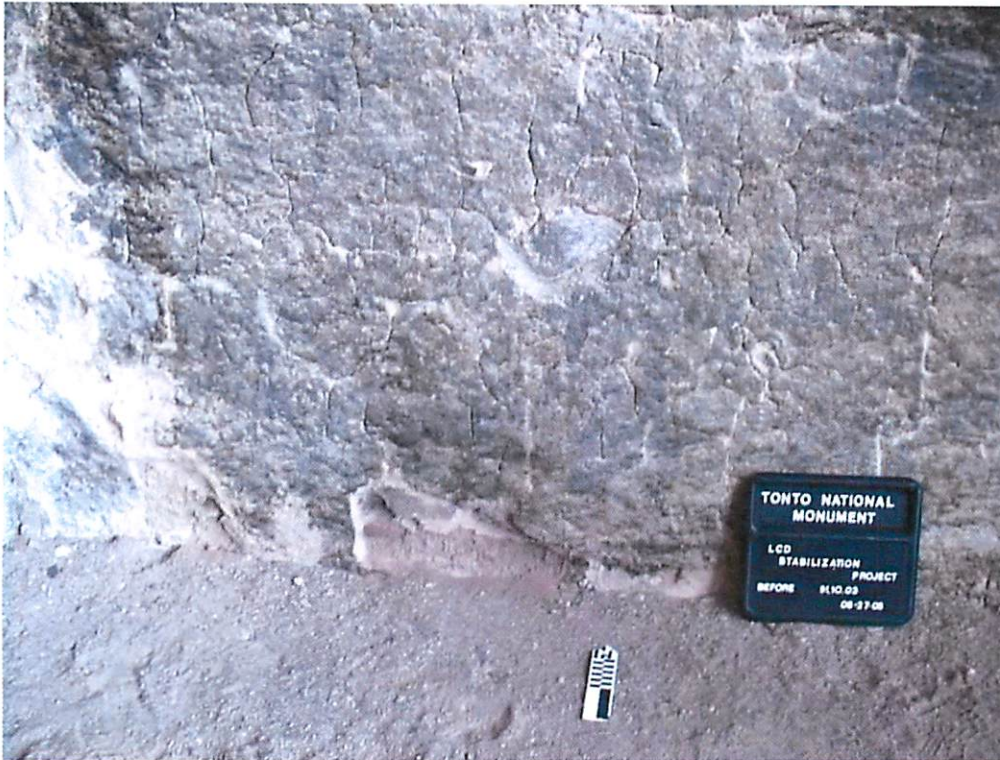
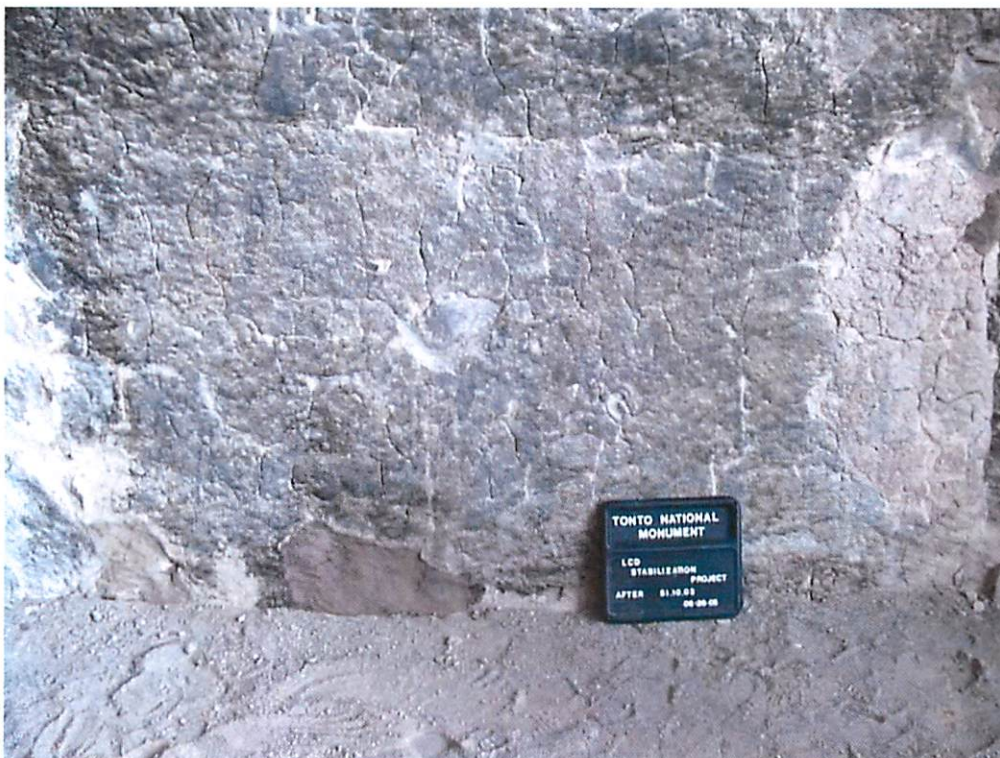
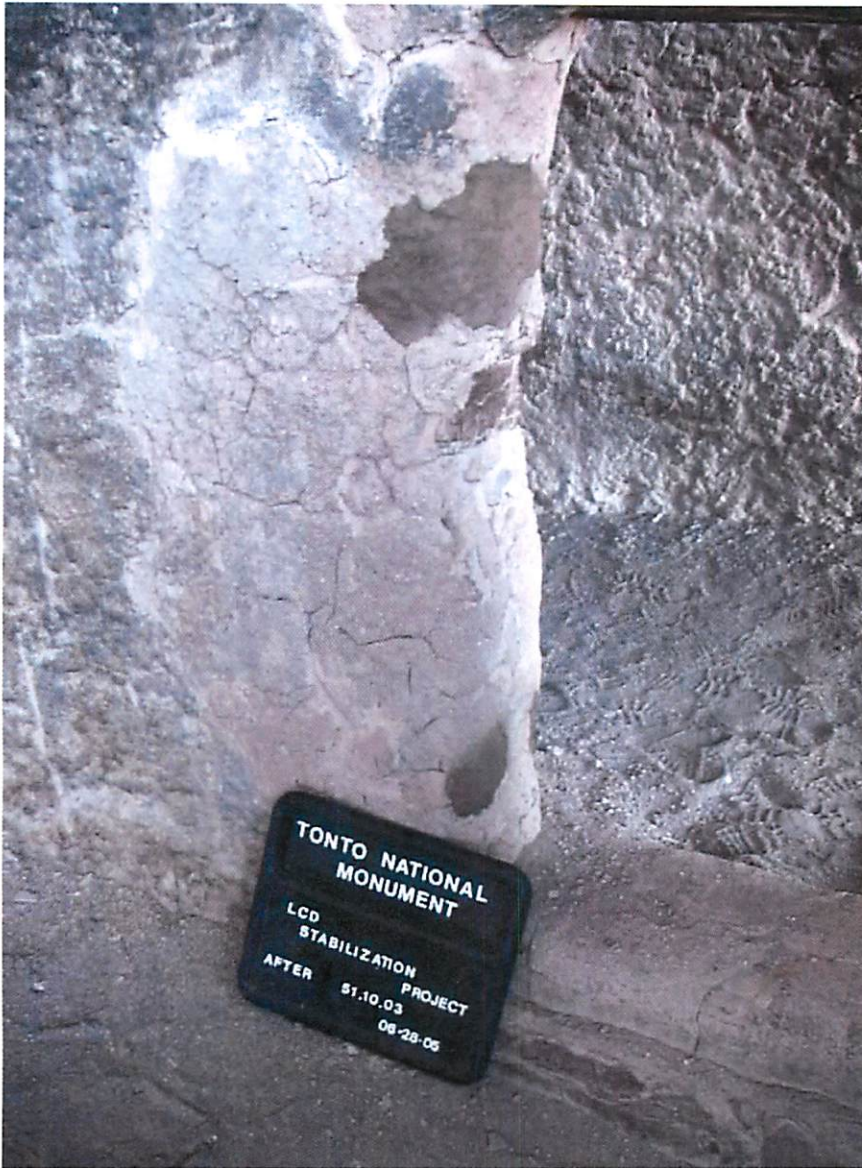
Room 10 North Interior Wall, West End (51.10.03)

Figure 6. Before photo of wall 51.10.03.

Figure 7. After photo of wall 51.10.03.

Figure 8. After photo of wall 51.10.03, detail area of doorway between Rooms 9 and 10.

51.10.03 (Room 9/10 Doorway)

This historic fabric was repaired by Duane Hubbard using 800 (3 lbs) screened soil, 200 mL (1 lbs) stucco mix, 100 mL (.5 lbs) micro-beads, and 100 mL water. Hubbard applied a small patch applied to west side of doorway (mid-height). A slight amendment was used and abrasive micro-beads added as a marker.

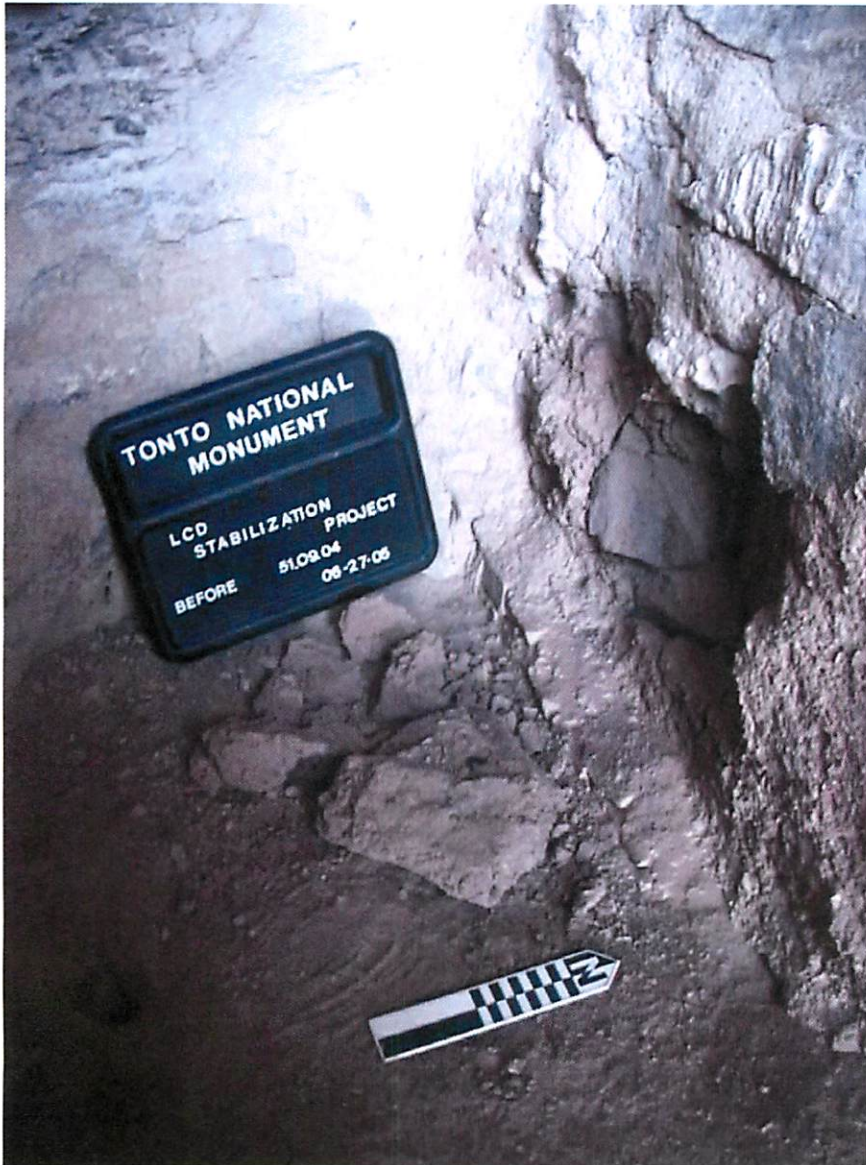
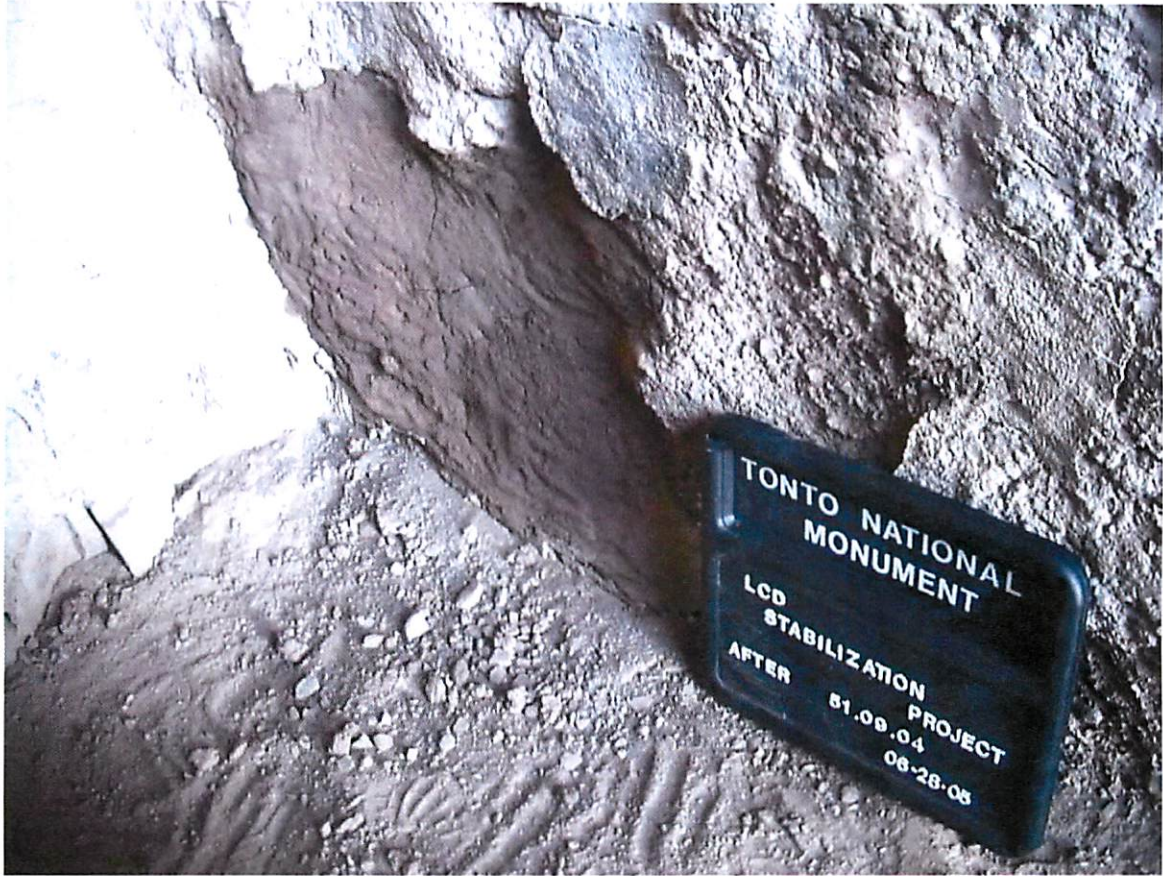
Room 9 North Interior Wall, West End (51.09.04)

Figure 9. Before photo of wall 51.09.04.

Figure 10. After photo of wall 51.09.04.

- 51.09.04
This historic fabric was repaired by Duane Hubbard using 1600 mL (6.5 lbs) screened soil, 400 mL (1.5 lbs) stucco mix, 200 mL (1 lbs) micro-beads, and 200 mL water. Hubbard applied a small patch to the wall base (west wall section) near northwest corner of room. A slight amendment was used and abrasive micro-beads added as a marker.
- 51.10.03
This historic fabric was repaired by Duane Hubbard using 1600 (6.5 lbs) screened soil, 400 mL (1.5 lbs) stucco mix 160 mL water, 200 mL (1 lbs) micro-beads, and 200 mL water. Hubbard applied a small patch to the wall base (middle wall section). A slight amendment was used and abrasive micro-beads added as a marker.

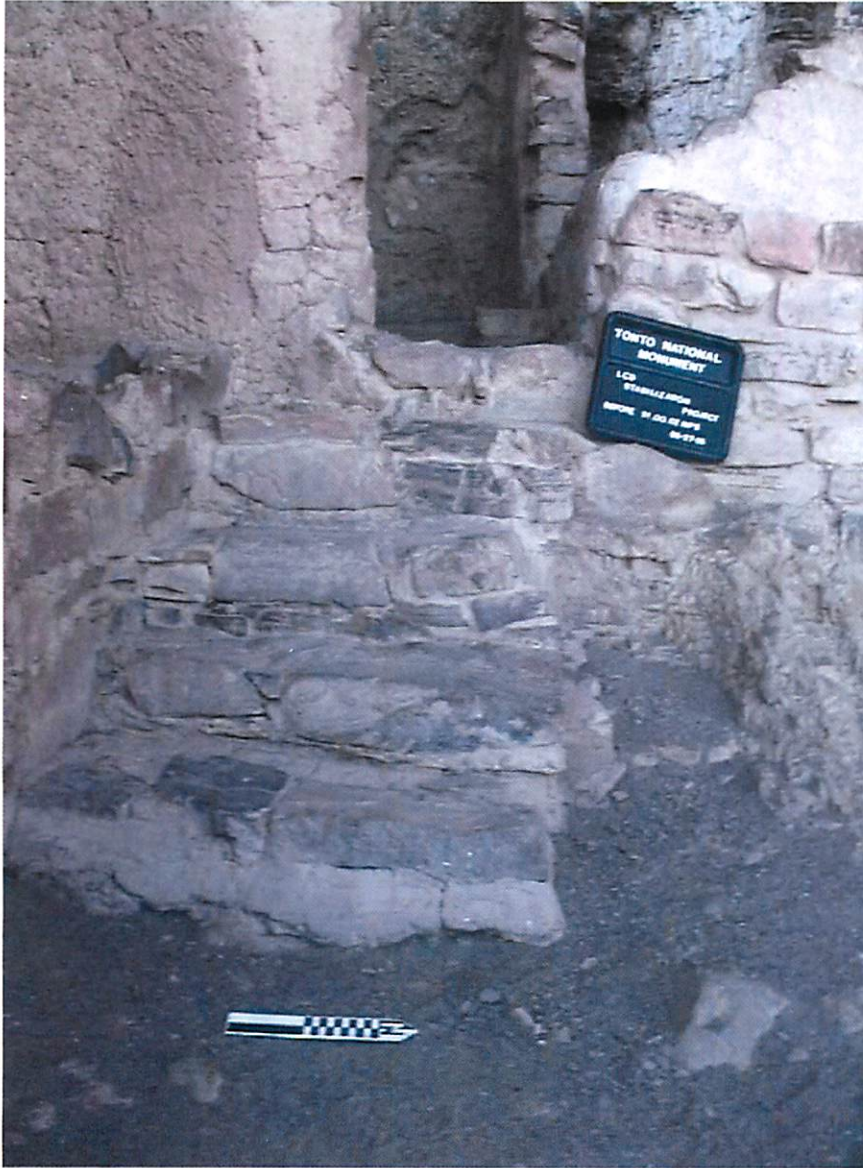
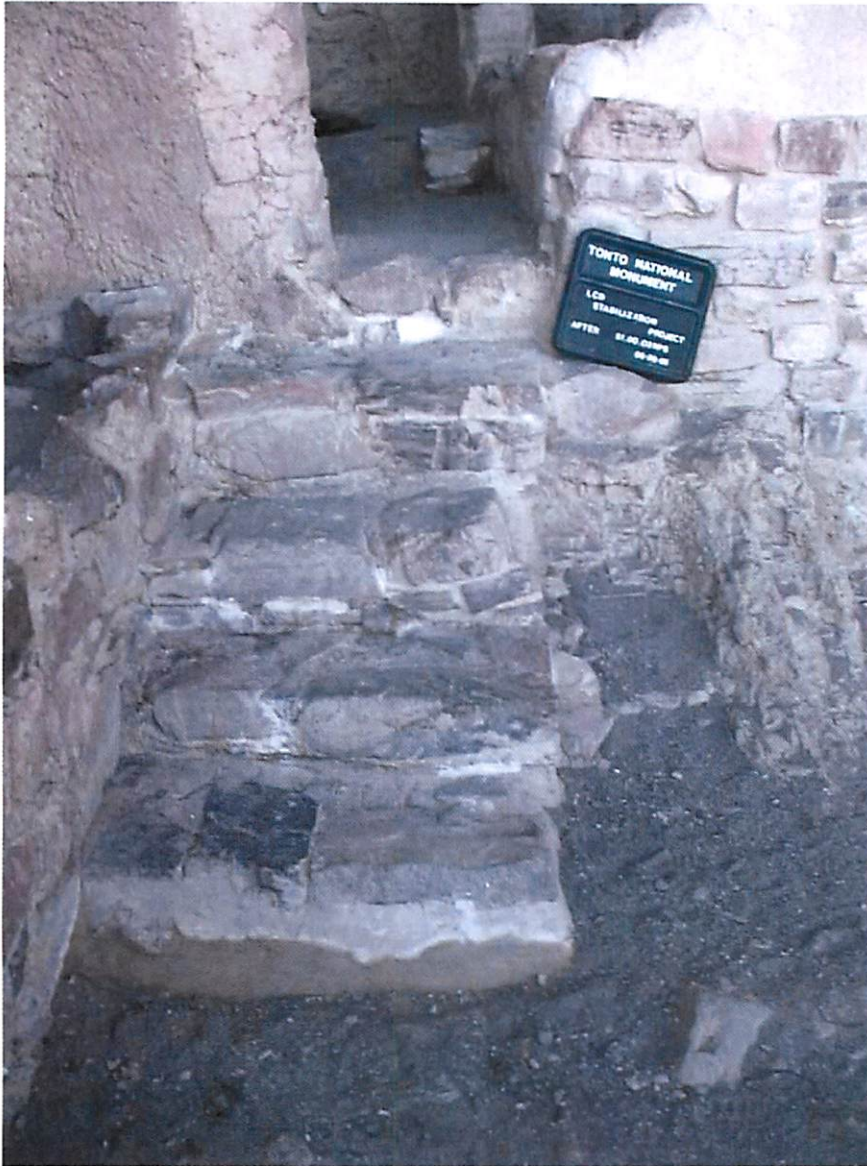
Steps leading from Room 2 into Room 11 (51.00.02NPS)

Figure 11. Before photo of NPS construction 51.00.02NPS.

Figure 12. After photo of NPS construction 51.00.02NPS.

- 51.00.02NPS
These modern steps were repointed by Matt Guebard using 3300 mL stucco mix (13 lbs) and 700mL water. The base section of the bottom stair was completely reconstructed. Small holes and cracked were filled throughout. Wet burlap was placed over the newly applied mix in order to reduce cracking.

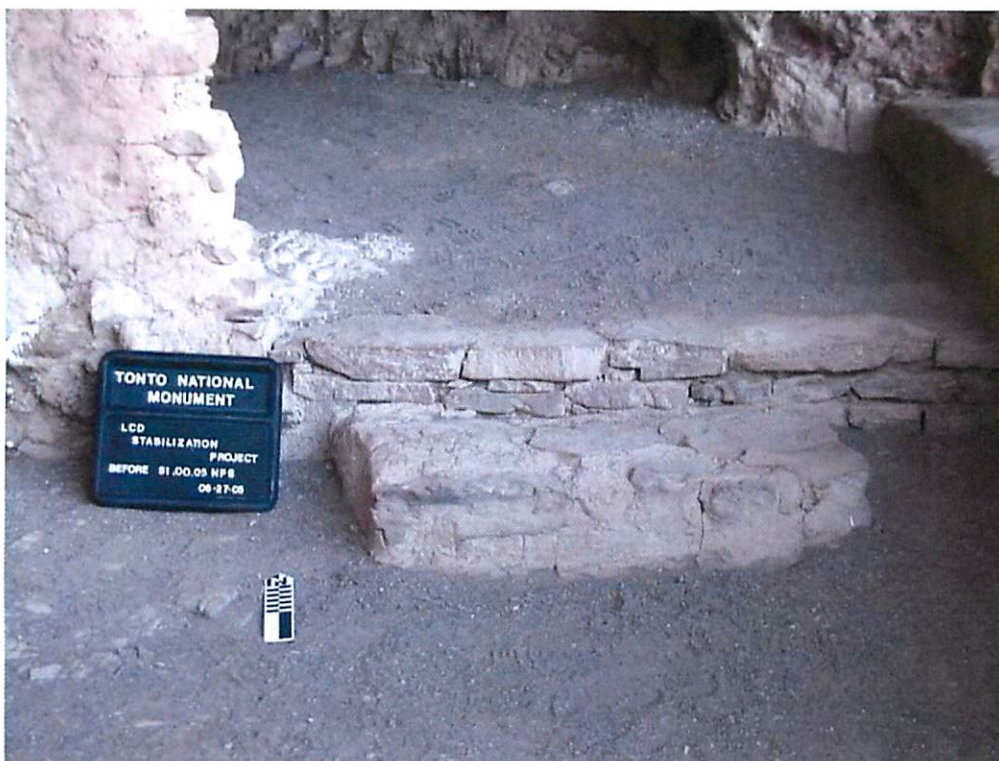
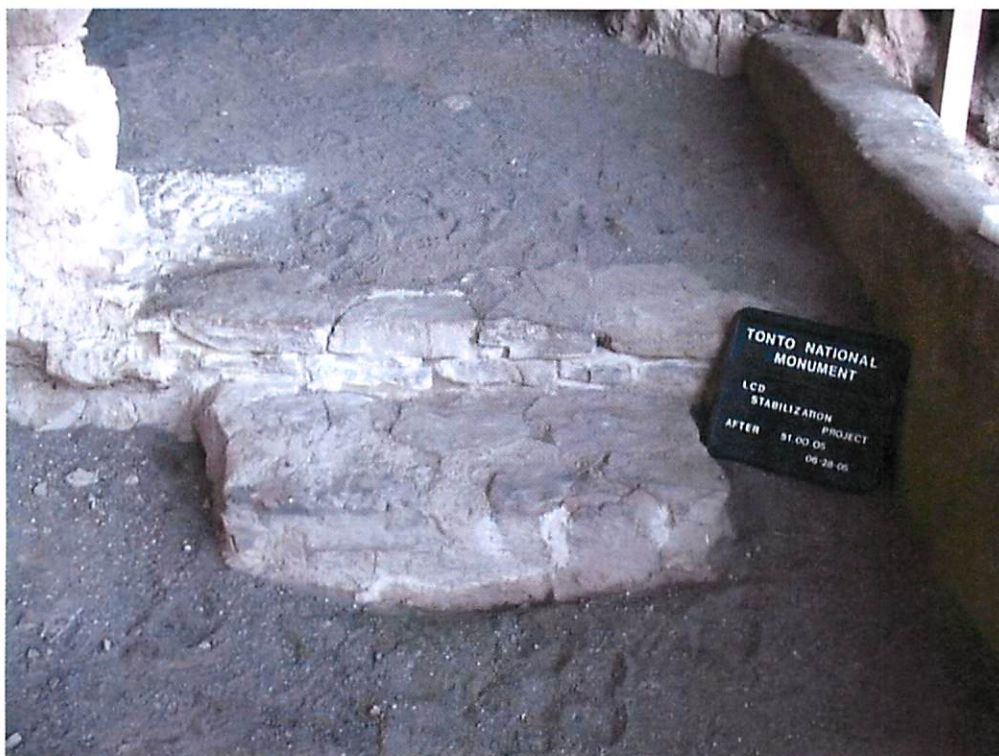
Steps leading from Room 4 into Room 5 (51.00.05NPS)

Figure 13. Before photo of NPS construction 51.00.05NPS.

Figure 14. After photo of NPS construction 51.00.05NPS.

- 51.00.05.NPS
These modern steps were repointed by Matt Guebard using 700mL stucco mix (3 lbs) and 70mL water. Extensive cracking and holes were filled throughout the entire southward facing portions of the stairs. Cracking was also filled at the base of the stairs. Cracking at the juncture between the retaining wall and stairs was filled. The sill of the top stair was made flush. Wet burlap was placed over the newly applied mix in order to reduce cracking.

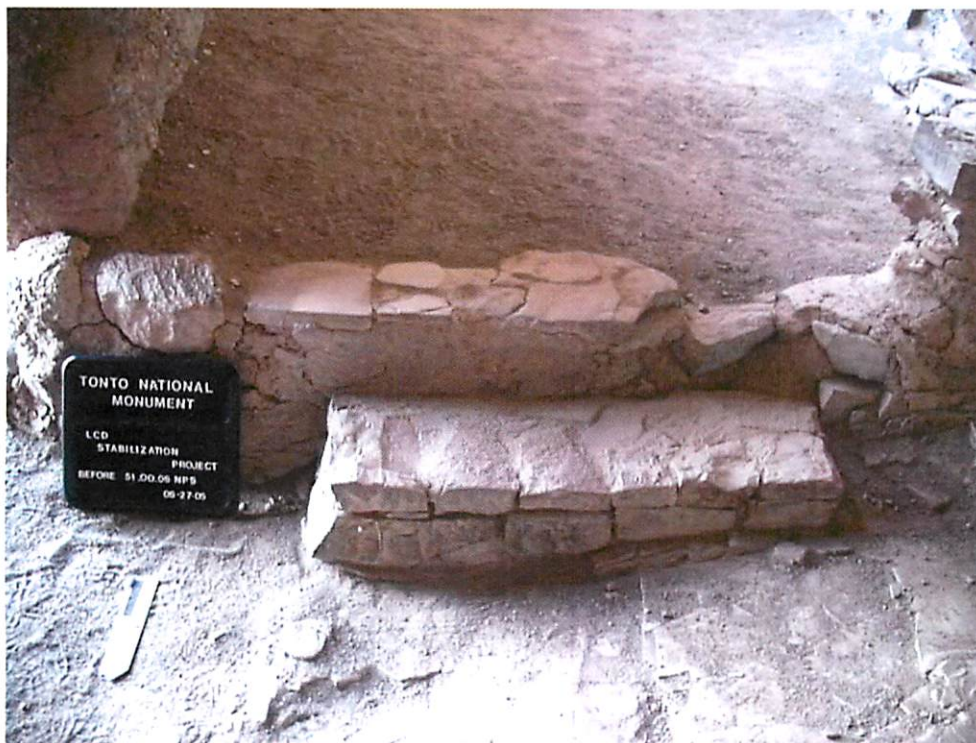
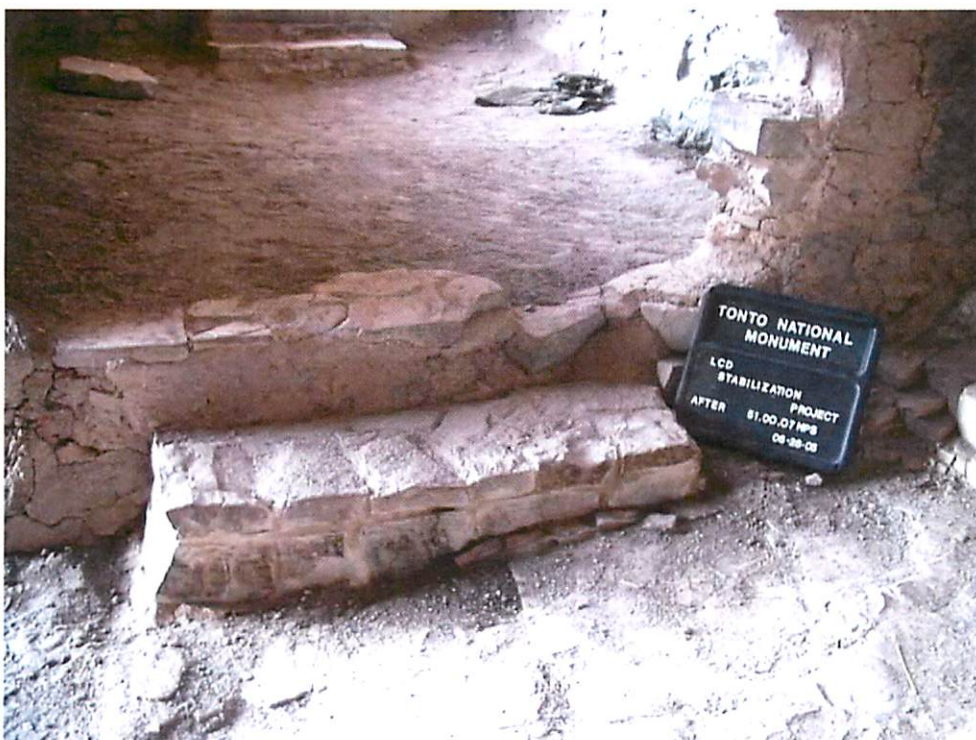
Steps leading from Room 5 into Room 6 (51.00.06NPS)

Figure 15. Before photo of NPS construction 51.00.06NPS.

Figure 16. After photo of NPS construction 51.00.06NPS.
(Note: photo board is incorrect.)

- 51.00.06NPS
These modern steps were repointed by Jeanne Stevens Schofer using 2100 mL stucco mix (8 lbs) and 400 mL water. Wet burlap was placed over the newly applied mix in order to reduce cracking.

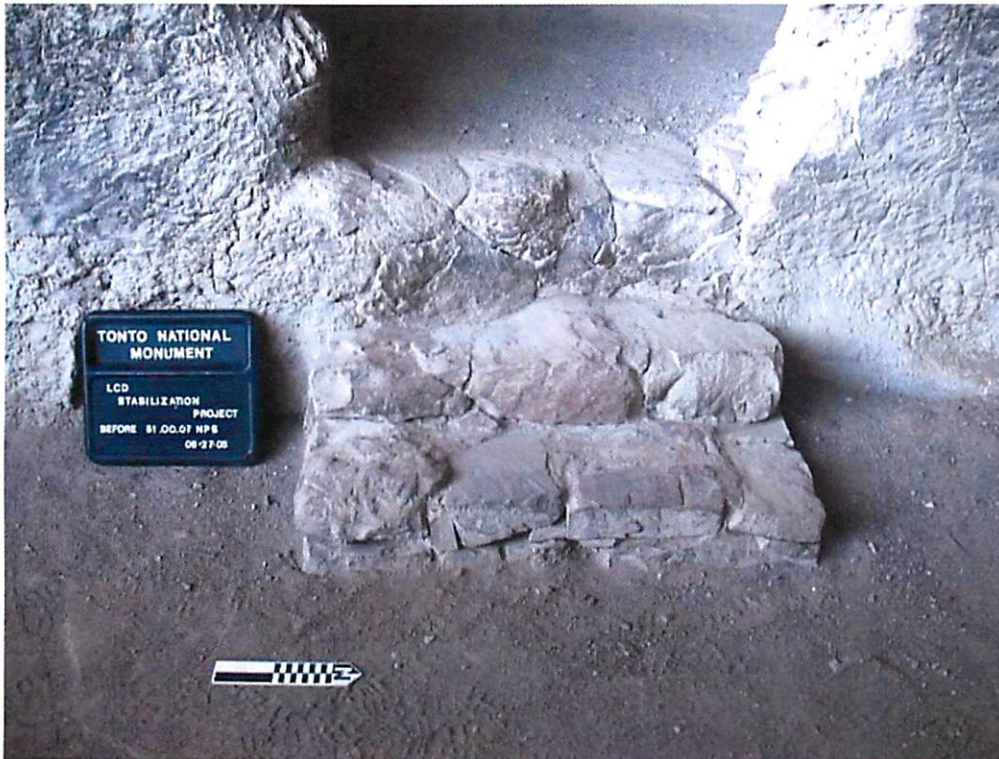
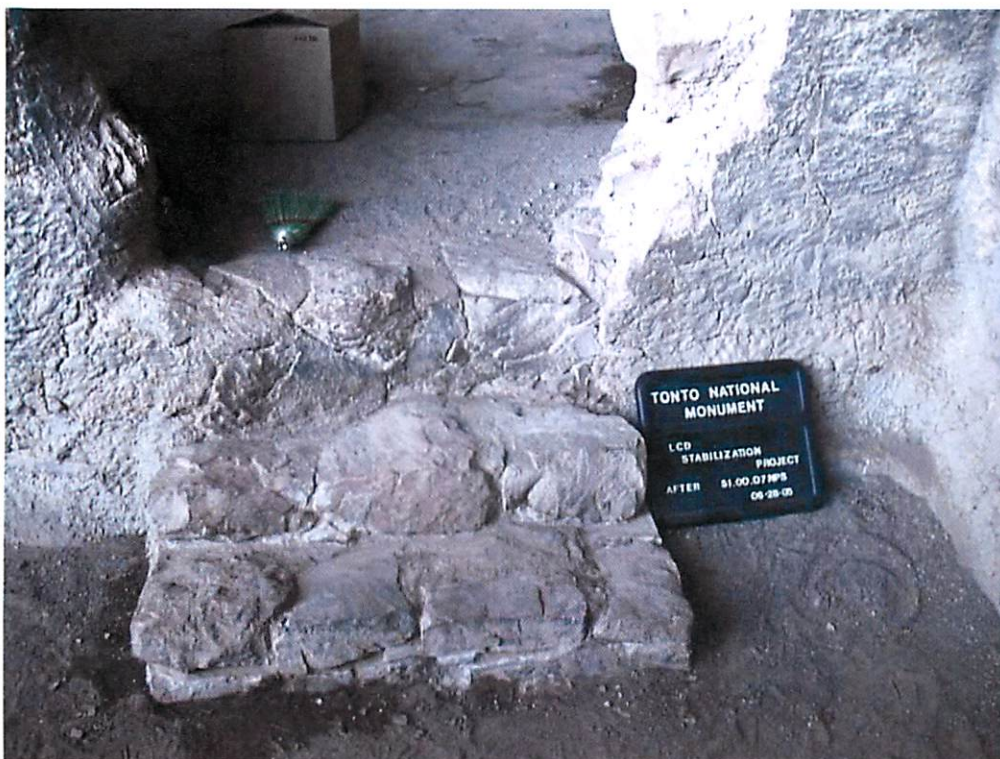
Steps leading from Room 6 into Room 16 (51.00.07NPS)

Figure 17. Before photo of NPS construction 51.00.07NPS.

Figure 18. After photo of NPS construction 51.00.07NPS.

- 51.00.07NPS
These modern steps were repointed by Matt Guebard using 1000 mL stucco mix (4 lbs) and 150 mL water. The majority of work was done around the base of the stairs and the juncture between the stairs and the wall. Wet burlap was placed over the newly applied mix in order to reduce cracking.

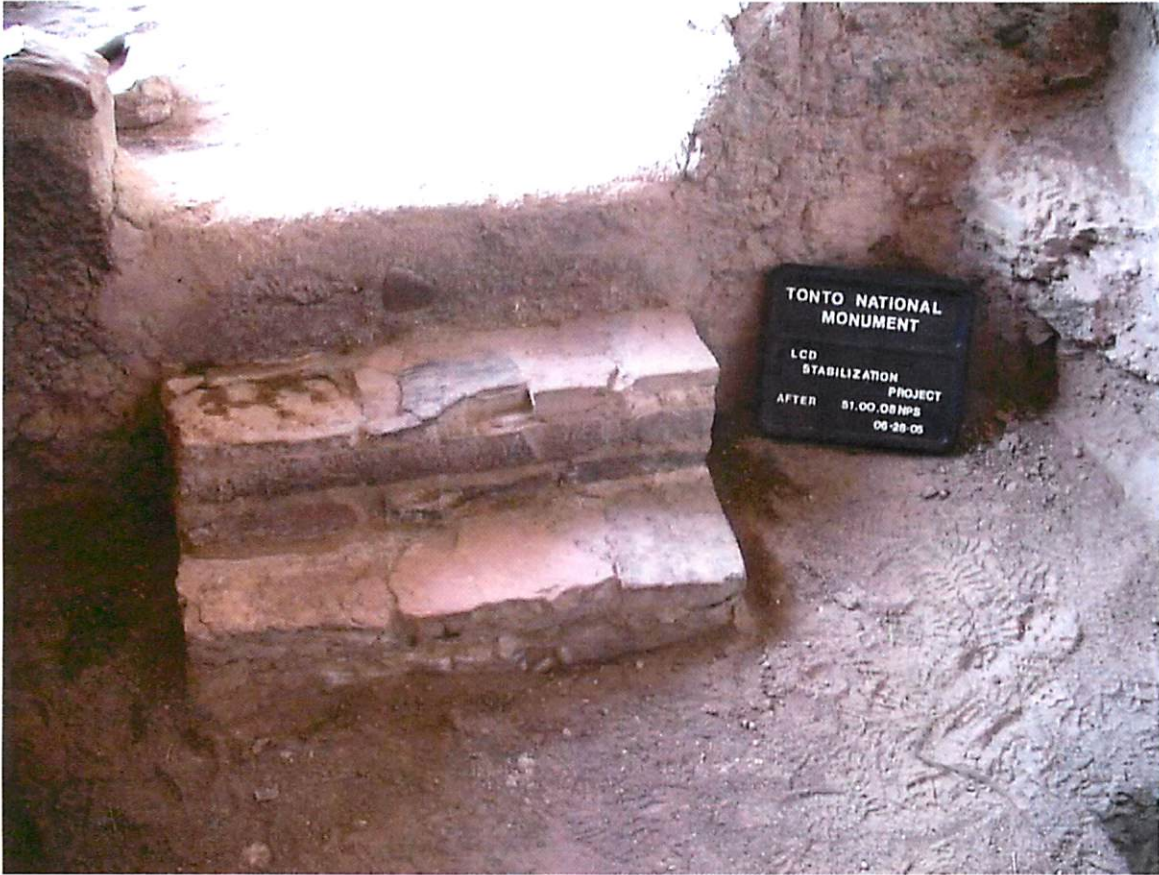
Steps leading from Room 6 into Room 7 (51.00.08NPS)

Figure 19. After photo of NPS construction 51.00.08NPS.

- 51.00.08NPS
These modern steps were repointed by Matt Guebard using 200 mL stucco mix (1 lbs) and 20mL water. The entire mixture was used to fill the northward facing joint separating the first and second stair. Wet burlap was placed over the newly applied mix in order to reduce cracking.

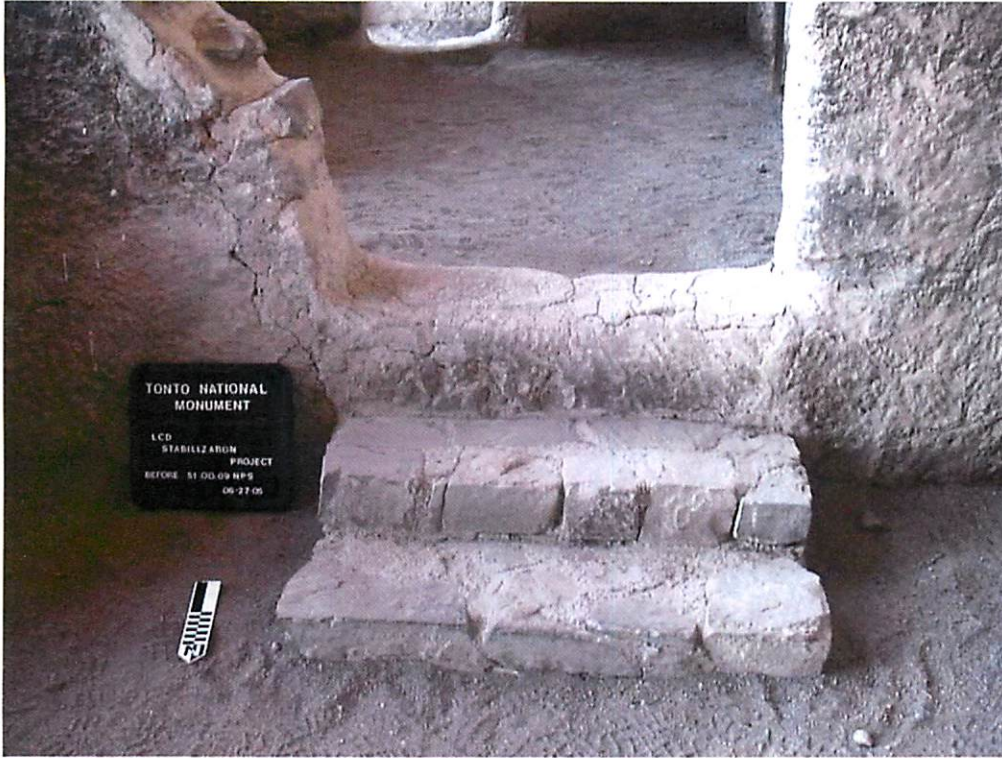
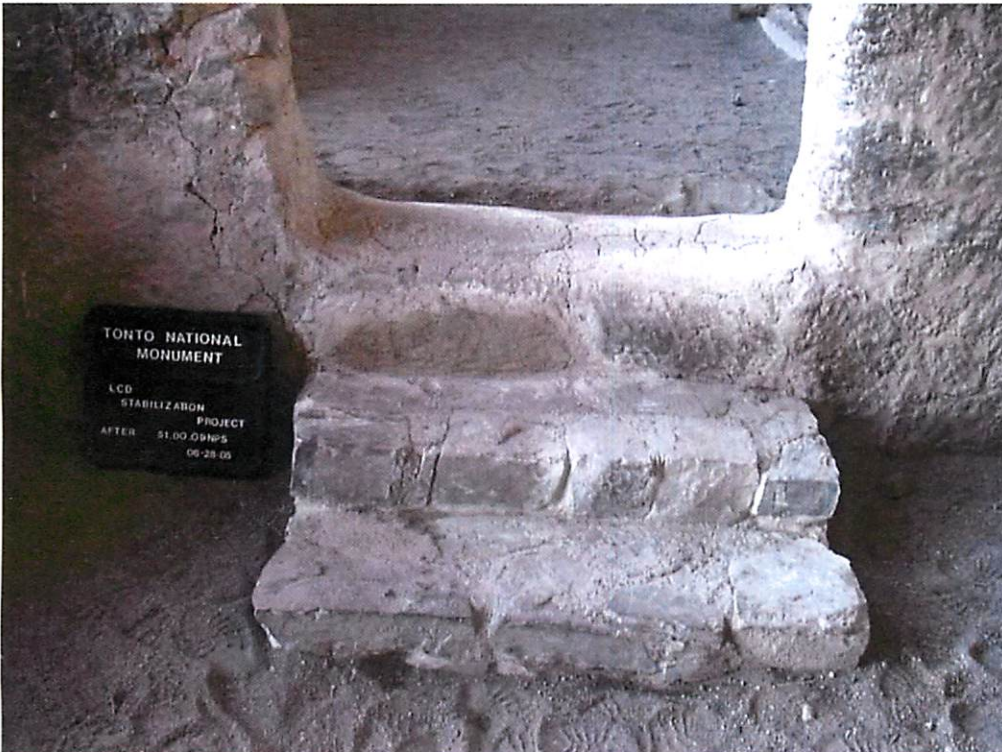
Steps leading from Room 7 into Room 8 (51.00.09NPS)

Figure 20. Before photo of NPS construction 51.00.09NPS.

Figure 21. After photo of NPS construction 51.00.09NPS.

- 51.00.09NPS
These modern steps were repointed by Jeanne Stevens Schofer using 2400 mL stucco mix (9 lbs) and 600 mL water. Wet burlap was placed over the newly applied mix in order to reduce cracking.

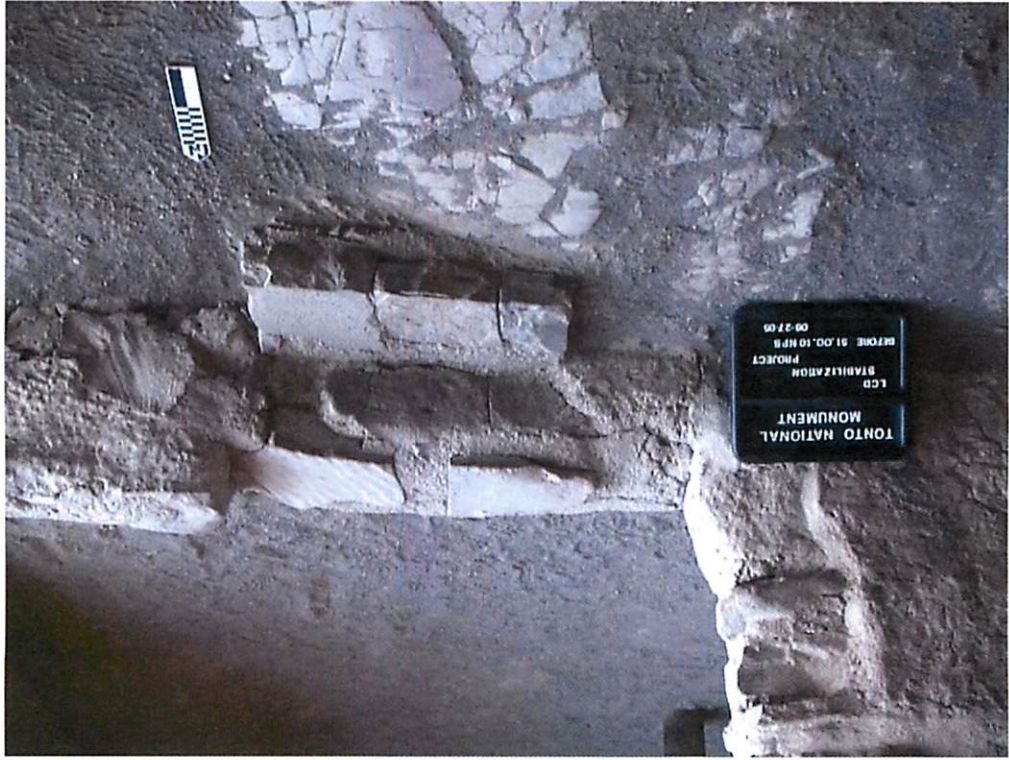
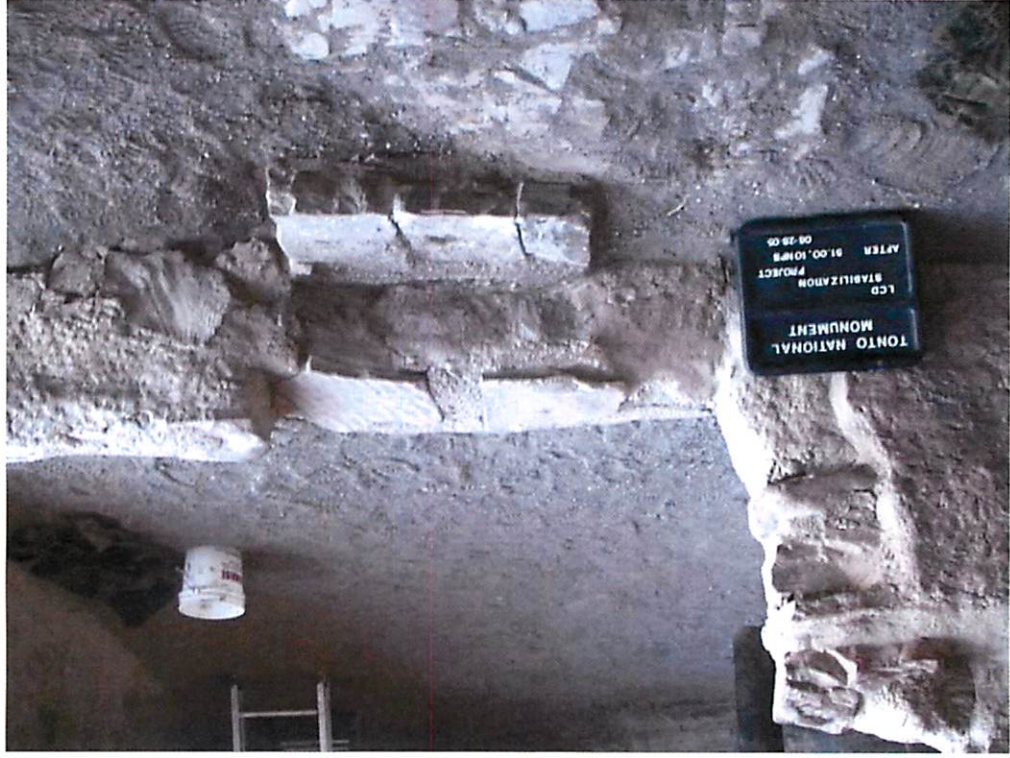
Steps leading from Room 11 to Room 10 (51.00.10NPS)

Figure 22. Before photo of NPS construction 51.00.10NPS.

Figure 23. After photo of NPS construction 51.00.10NPS.

- 51.00.10NPS
These modern steps were repointed by Jeanne Stevens Schofer using 2200 mL stucco mix (8 lbs) and 550 mL water. Wet burlap was placed over the newly applied mix in order to reduce cracking.

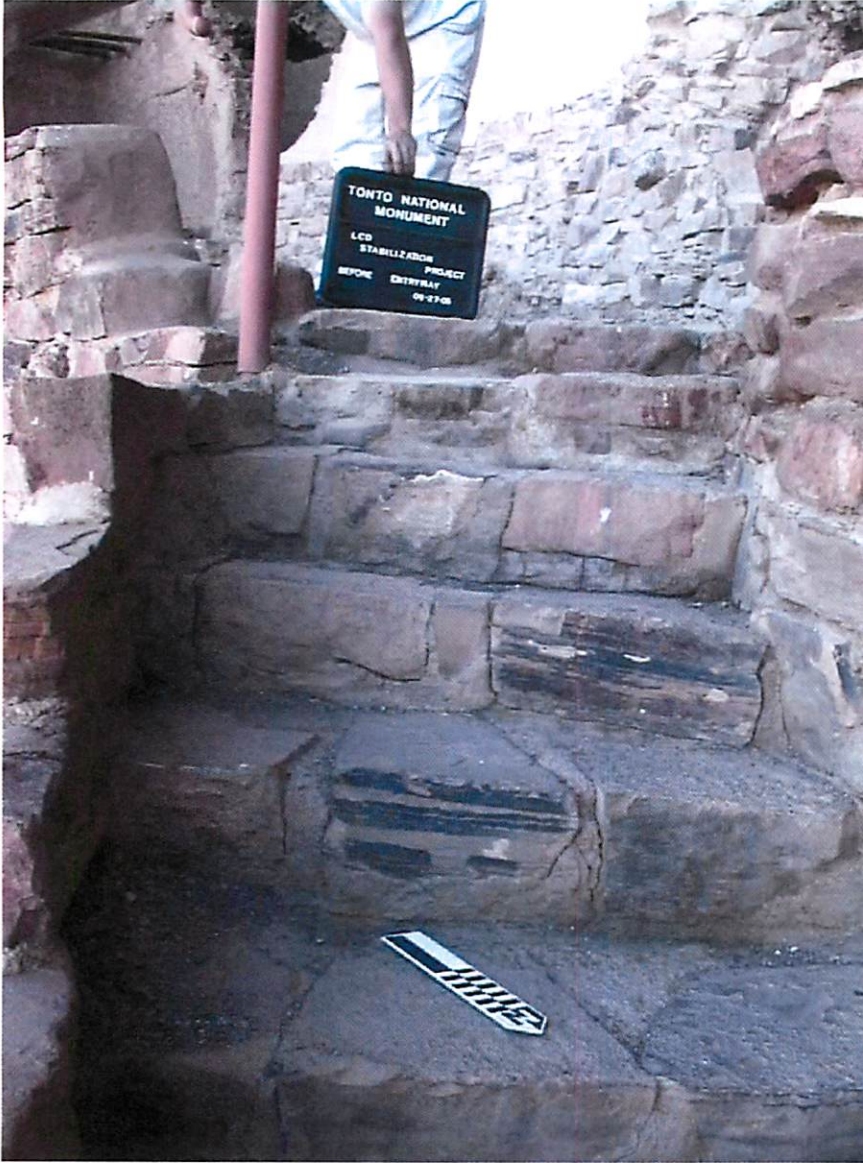
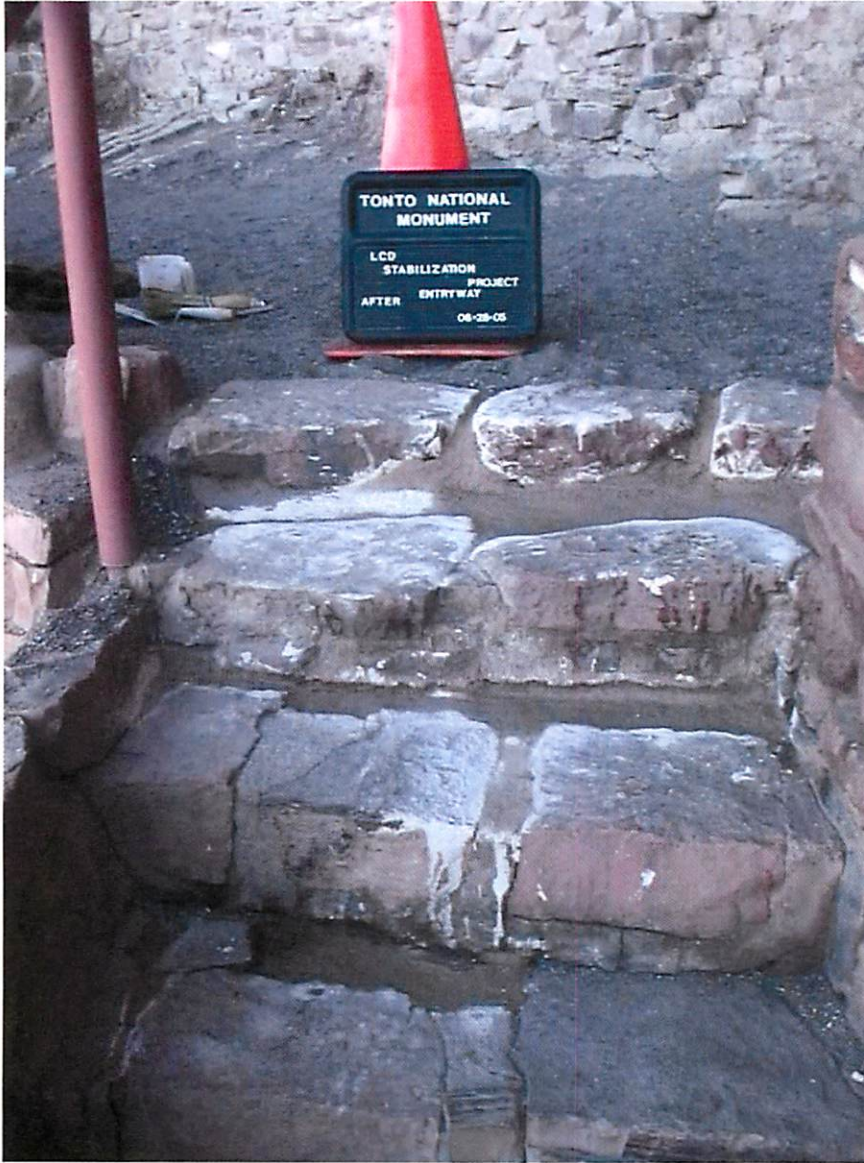
Figure 24. Before photo of NPS construction entryway steps.

Figure 25. After photo of NPS construction entryway steps.

- LCD entryway steps
These modern steps were repointed by Jeanne Stevens Schofer and Matt Guebard using 3000 mL stucco mix (12 lbs) and 700 mL water. This included filling cracks as well as making the first step uniformly flush with masonry stones. Wet burlap was placed over the newly applied mix in order to reduce cracking.
