# **HISTORIC STRUCTURE REPORT**

## **RANGER CABIN & BOUNDARY FENCE**

### **WALNUT CANYON NATIONAL MONUMENT**

March 2007

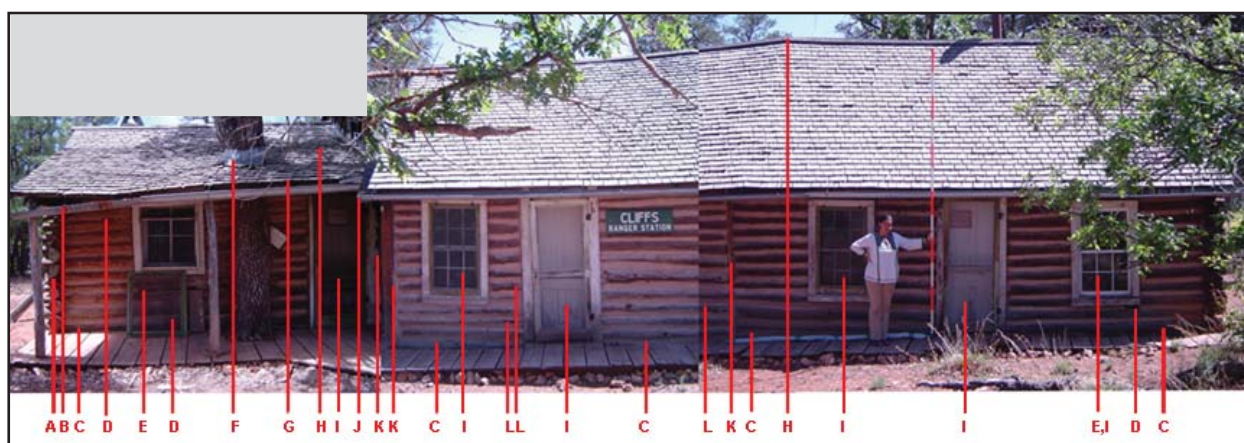
Fig. 17: Composite photograph of north elevation showing condition deficiencies, 2006 (letters refer to notes in the Condition Assessment Table below; see Appendix A for larger image)

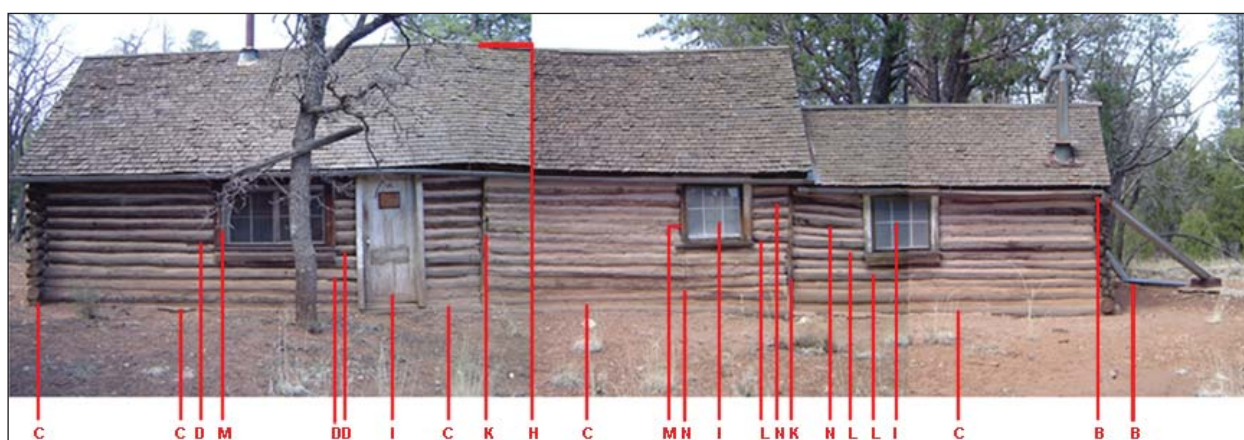
Fig. 18: Composite photograph of south elevation showing condition deficiencies, 2006 (letters refer to notes in the Condition Assessment Table below; see Appendix A for larger image)

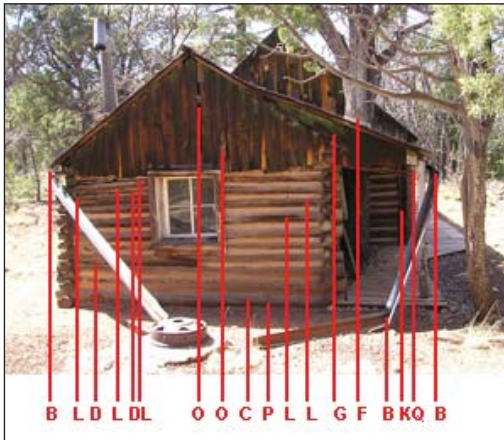
Fig. 19: East elevation showing condition deficiencies, 2006 (letters refer to notes in the Condition Assessment Table below; see Appendix A for larger image)

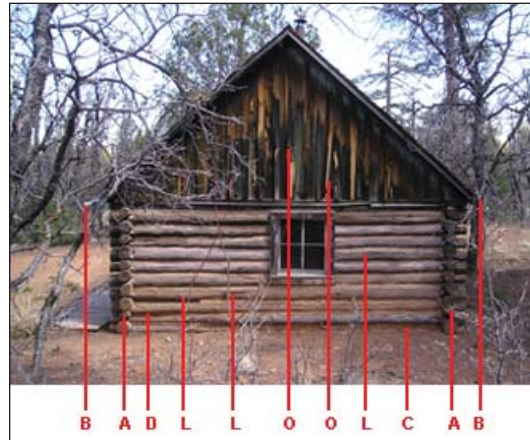
Fig. 20: West elevation showing condition deficiencies, 2006 (letters refer to notes in the Condition Assessment Table below; see Appendix A for larger image)

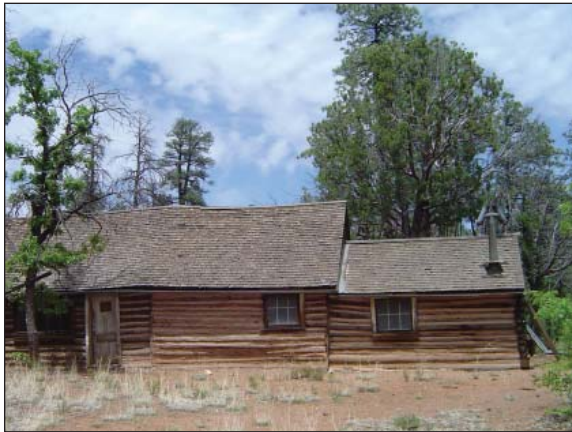
Fig. 30: South elevation showing ridge in roof between original cabin and second addition, 2006.

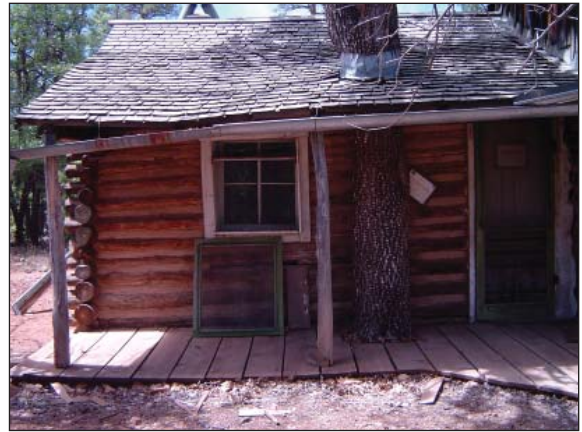
Fig. 31: Kitchen addition on north elevation showing improper roof slope, 2006.

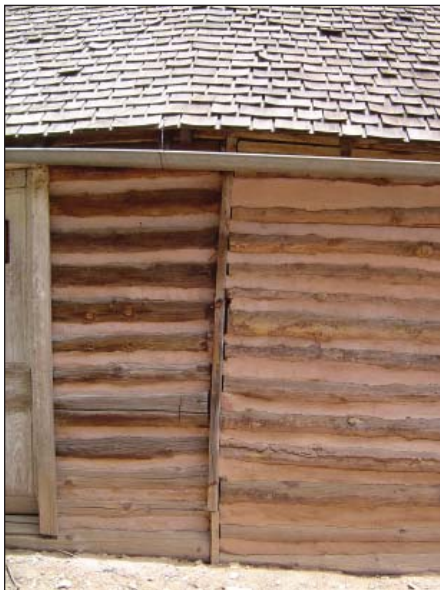
Fig. 32: Connection between original cabin and second addition does not provide adequate structural support, 2006.

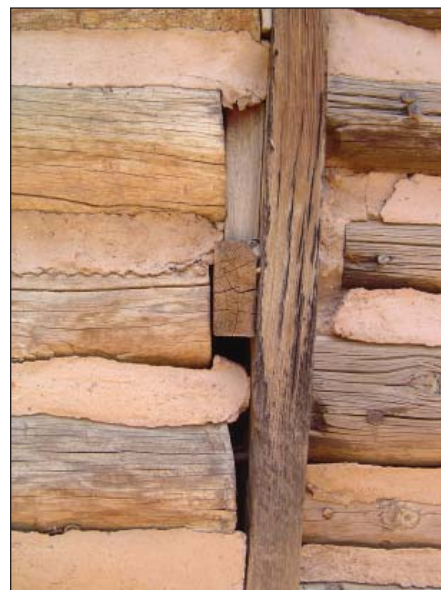
Fig. 33: Detail of connection between original cabin and second addition showing logs attached to a vertical wood post, 2006.

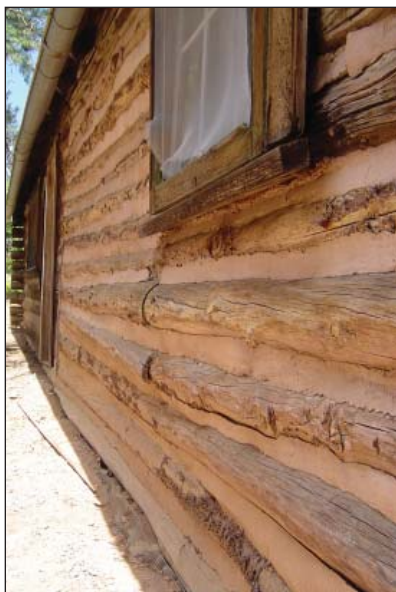
Fig. 34: Bowed wall under window on original cabin where historic chimney once existed, 2006.

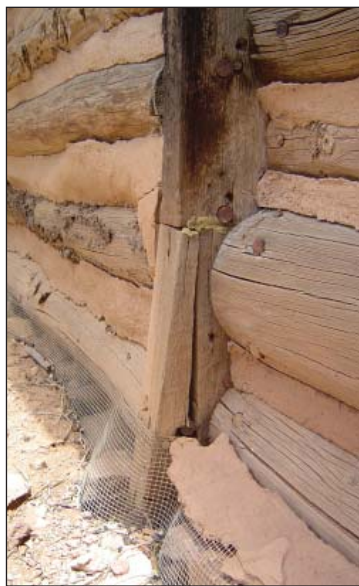
Fig. 35: Cracked member at hog-trough corner between original cabin and kitchen addition provides inadequate structural stability, 2006.

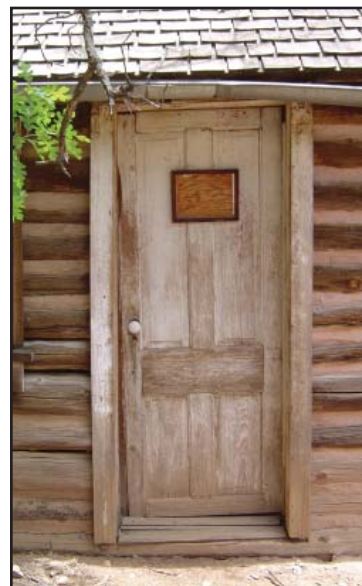
Fig. 36: Door askew on the south elevation of the second addition, 2006.

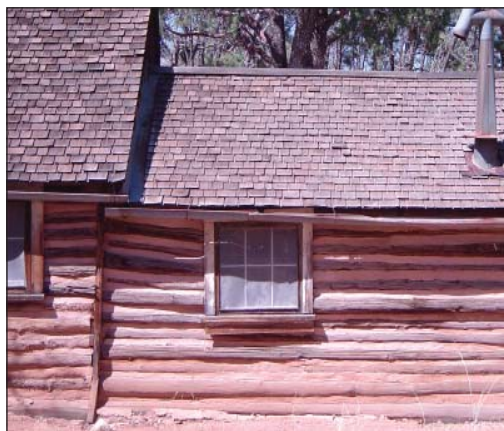
Fig. 37: South elevation of kitchen addition showing improperly tied logs angled toward window, 2006.

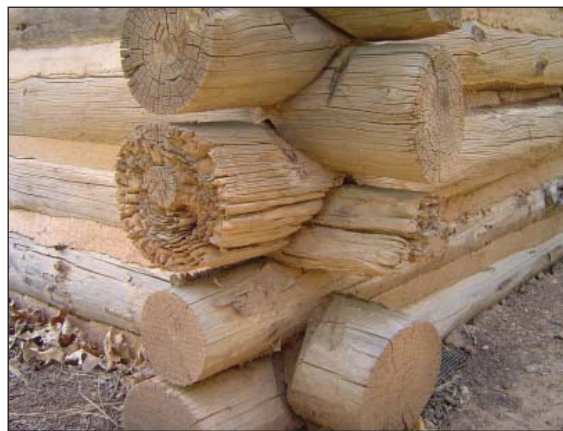
Fig. 38: Decayed crowns at northeast corner, 2006.

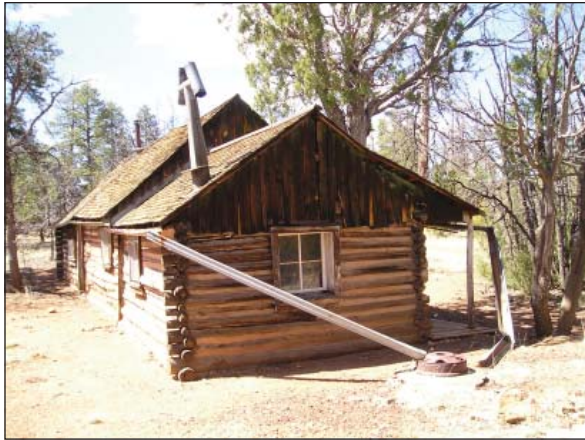
Fig. 39: East elevation showing drainage toward building and displaced gutter, 2006.

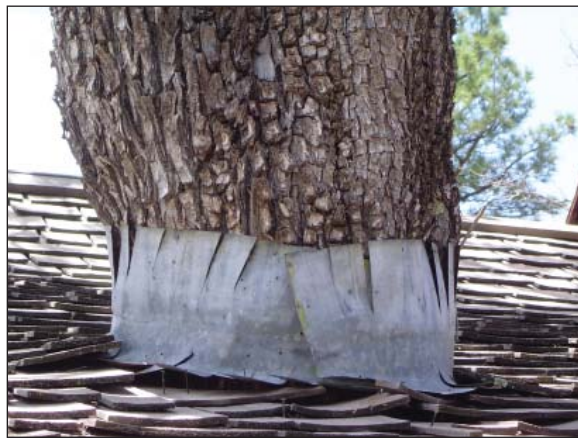
Fig. 42: Flashing around tree at kitchen roof does not provide water-proof seal, 2006.

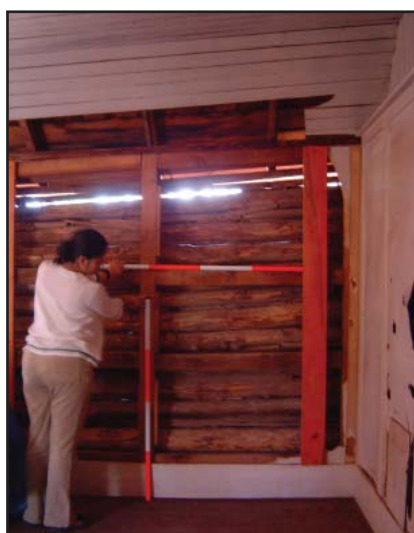
Fig. 45: South wall of Room One showing ceiling damage, missing wallboard, and exposure to exterior, 2006.

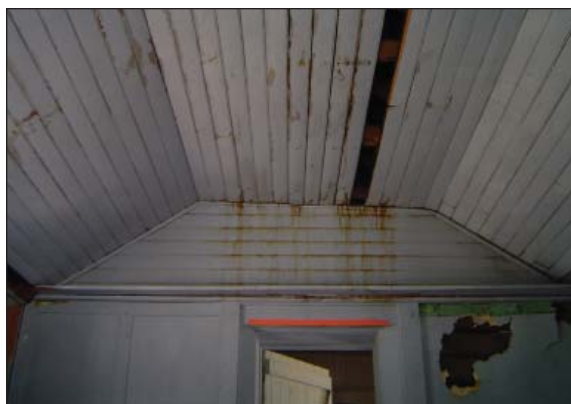
Fig. 48: West wall and ceiling of Room Two showing ceiling and wall damage, including presence of unidentified sticky substance, 2006.

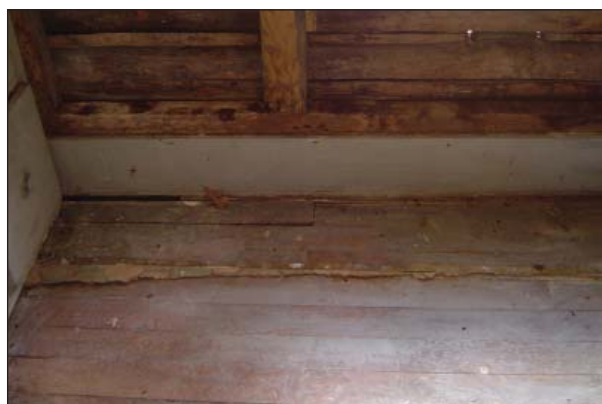
Room Two Deficiency	Recommended Treatment*	Impact
Presence of linoleum flooring over wood floor and discoloration of wood floor. (Fig. 49)	Remove traces of linoleum flooring and accession into museum collection.	Low
Evidence of rodent infestation.	Seal building at perimeter with rodent-proof mesh. Daub and chink between logs. Seal gap between wall and roof members with preformed metal tie down straps.	Severe
* Note: Please see <i>Requirements for Treatment</i> for additional information on each recommendation.

Fig. 49: Northeast corner of Room Two showing linoleum flooring over wood, 2006.

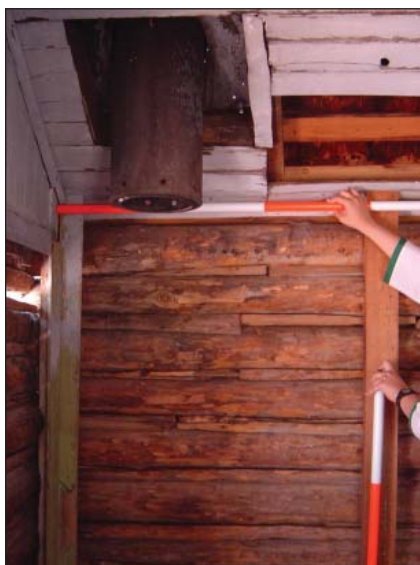
Fig. 50: Ceiling and south wall condition of Room Two, 2006.

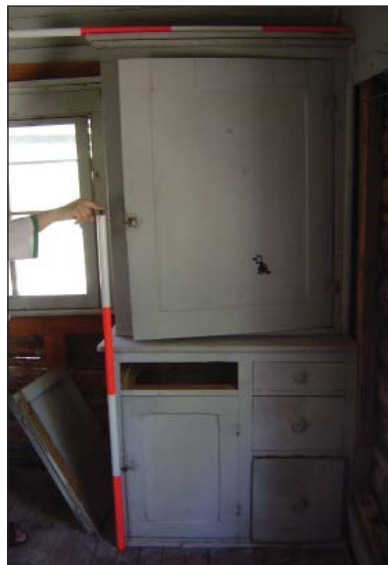
Fig. 51: Built-in storage showing missing drawer and damage to west side, 2006.

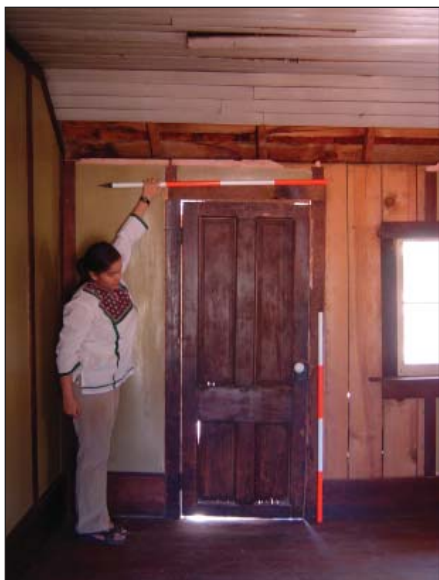
Fig. 53: North wall of Room Three showing ceiling damage, missing wallboard, and dark stained trim, 2006.

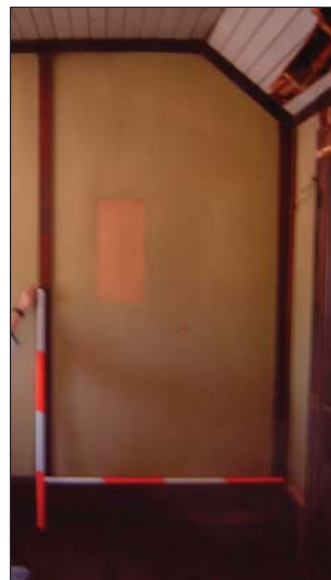
Fig. 55: West wall of Room Three (to the right of Fig. 54) showing stain where telephone was once mounted, 2006.

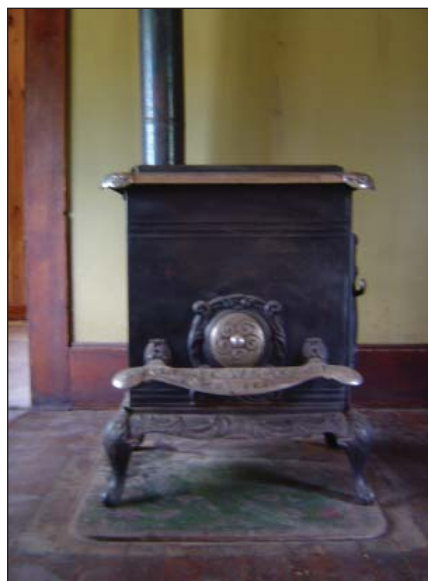
Fig. 57: Stove in Room Three showing floor damage, 2006.

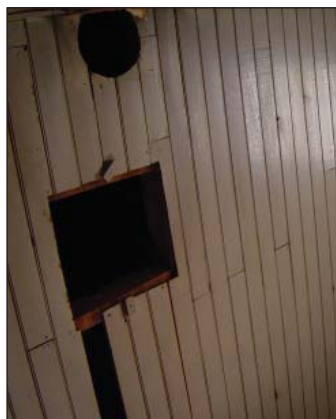
Fig. 59: Ceiling damage in Room Four, 2006.

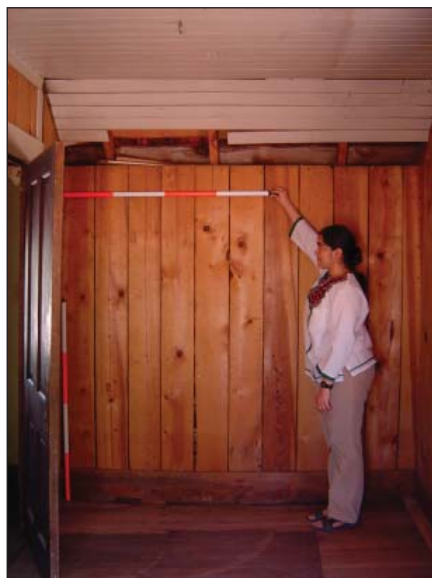
Fig. 60: South wall of Room Four showing ceiling damage and wall condition, 2006.

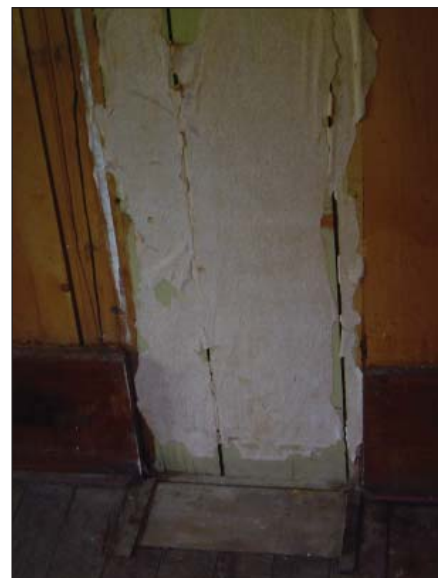
Fig. 61: East wall of Room Four showing wallpaper and floor damage, 2006.

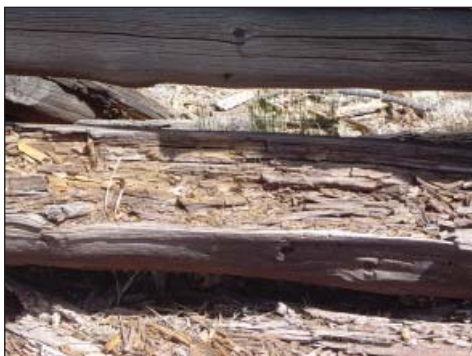
Fig. 12: Rotted log, 2006.

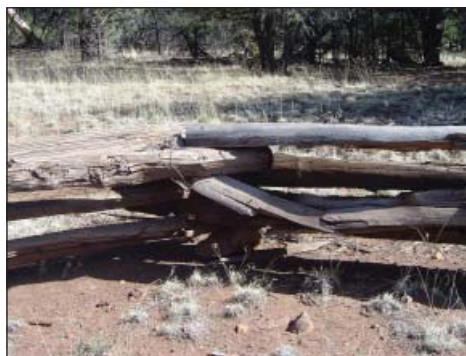
Fig. 13: Failure and collapse at junction, 2006.

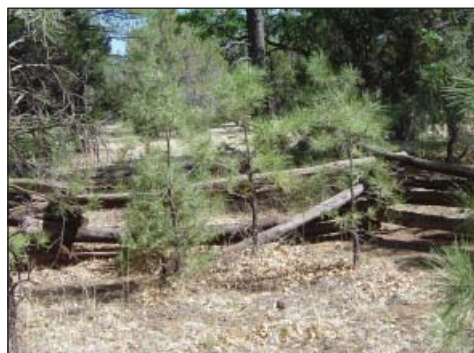
Fig. 14: Cracked and displaced log, 2006.

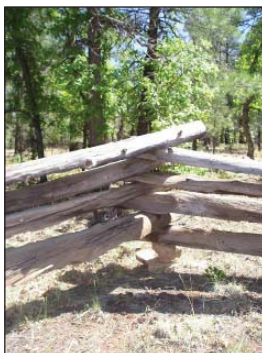
Fig. 15: Bottom logs rests upon two stones, 2006.

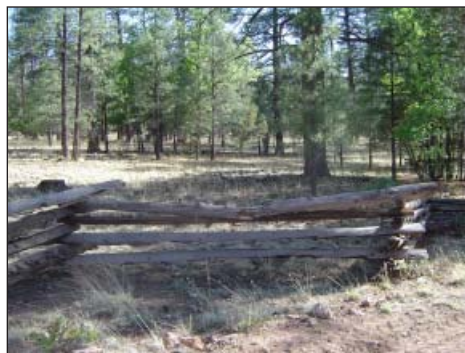
Fig. 16: Cracked top log, 2006.
