**Bury Hall Renovation  
NAU Project #09.080.241  
October 20, 2023**

**ADDENDUM #1**

**ATTACHMENT E – FACILITY CONDITION ASSESSMENT FOR BURY HALL**

## Facility Condition Assessment

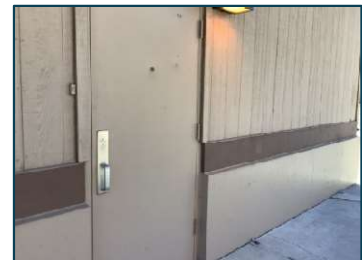
Based on the on-site visual inspection, the exterior siding, windows, and roofing appear to be in generally poor condition and outdated. Replacing these assets will be important to maintaining the integrity of the structure and ensuring water tightness.

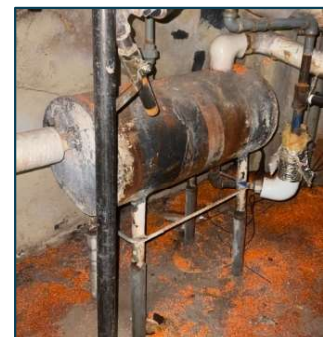
Much of the building's HVAC equipment is outdated, due to the age of the building. Replacing these assets will be critical to preventing any disruptions to operations caused by mechanical failures. Note, the heating water system was recently abandoned in favor of steam. However, replacement of the outdated steam equipment (including radiators) with heating water systems is recommended.

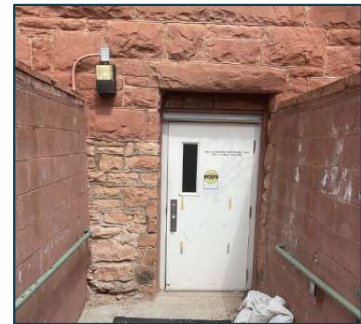
The exterior doors are outdated, and in poor condition. Replacement should be prioritized to maintain building security. Additionally, the exterior masonry walls are in somewhat poor condition due to erosion and grout deterioration. Refurbishment of the masonry walls is recommended within 5 years. Note, the price included for the masonry walls is for a full replacement and represents a maximum upper bound cost.

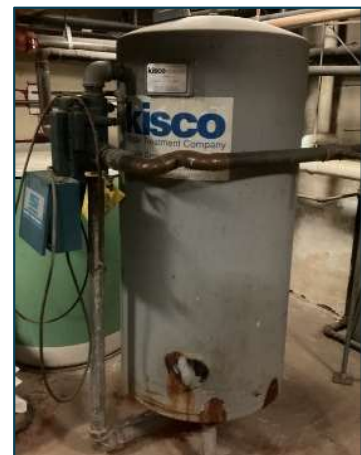
The water softener currently appears out of service, and in poor condition. Severe corrosion was noted on the bottom of the softener tank. Replacement of this asset is recommended as soon as feasible.

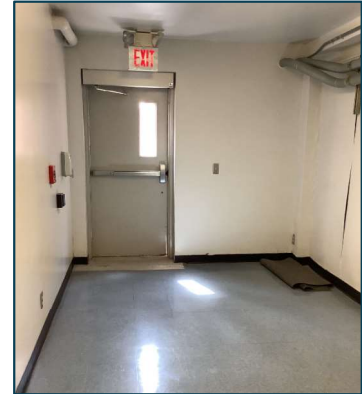
The interior finishes (including carpeting, VCT flooring, stairwells, and drywall walls) are generally in somewhat poor condition due to age and are recommended for replacement. A portion of the drywall walls adjacent to the exterior perimeter were noted to have water damage, especially on the southwest corner of the building. On average, these assets were originally installed between 15-30 years ago.

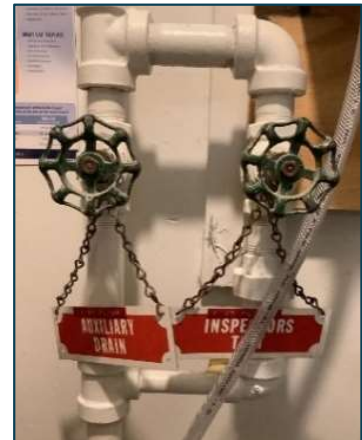
The fire suppression/sprinkler system appears to have been originally installed in 1982 and is now outdated. Updates and refurbishment should be prioritized for this system within 5 years, to ensure full system functionality when needed.

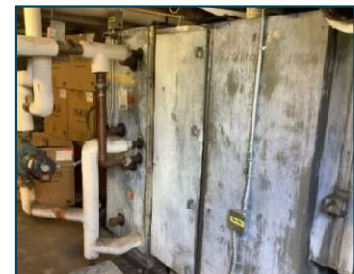
The heating, ventilation, and air conditioning (HVAC) systems generally date from 1985 and are in poor condition. This includes the heating water generation system and air distribution system. A full system replacement (versus individual equipment replacements) is likely warranted within 5 years. Of note, the majority of the automation controls were converted to either full DDC or electronic pneumatic controls in 2013. Ideally, many of these controls can be repurposed as equipment is replaced.
