# Northern Arizona University – Education & Support Facilities

## Facility Condition Assessment

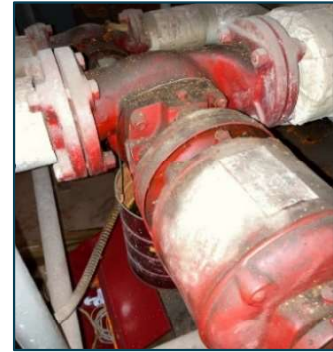
Much of the building's HVAC equipment is outdated, due to the age of the building. Replacing these assets will be critical to preventing any disruptions to operations caused by mechanical failures. Note, the heating water system was recently abandoned in favor of steam. However, replacement of the outdated steam equipment (including radiators) with heating water systems is recommended.

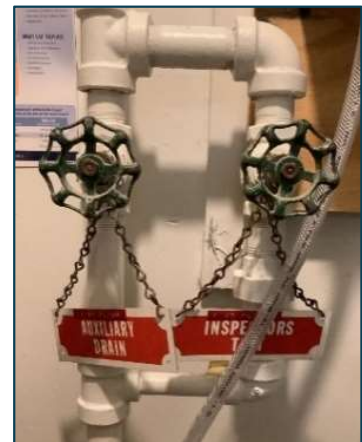
The fire suppression/sprinkler system appears to have been originally installed in 1982 and is now outdated. Updates and refurbishment should be prioritized for this system within 5 years, to ensure full system functionality when needed.

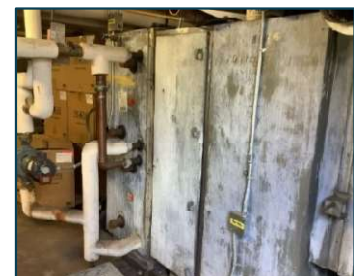
The heating, ventilation, and air conditioning (HVAC) systems generally date from 1985 and are in poor condition. This includes the heating water generation system and air distribution system. A full system replacement (versus individual equipment replacements) is likely warranted within 5 years. Of note, the majority of the automation controls were converted to either full DDC or electronic pneumatic controls in 2013. Ideally, many of these controls can be repurposed as equipment is replaced.
