# **The Influence of Ground Water Pumping On Wetlands in Crane Flat, Yosemite National Park, California**

**Report Prepared for: Yosemite National Park**

**David J. Cooper, Ph.D. and Evan C. Wolf, M.S.**

**March 2006**

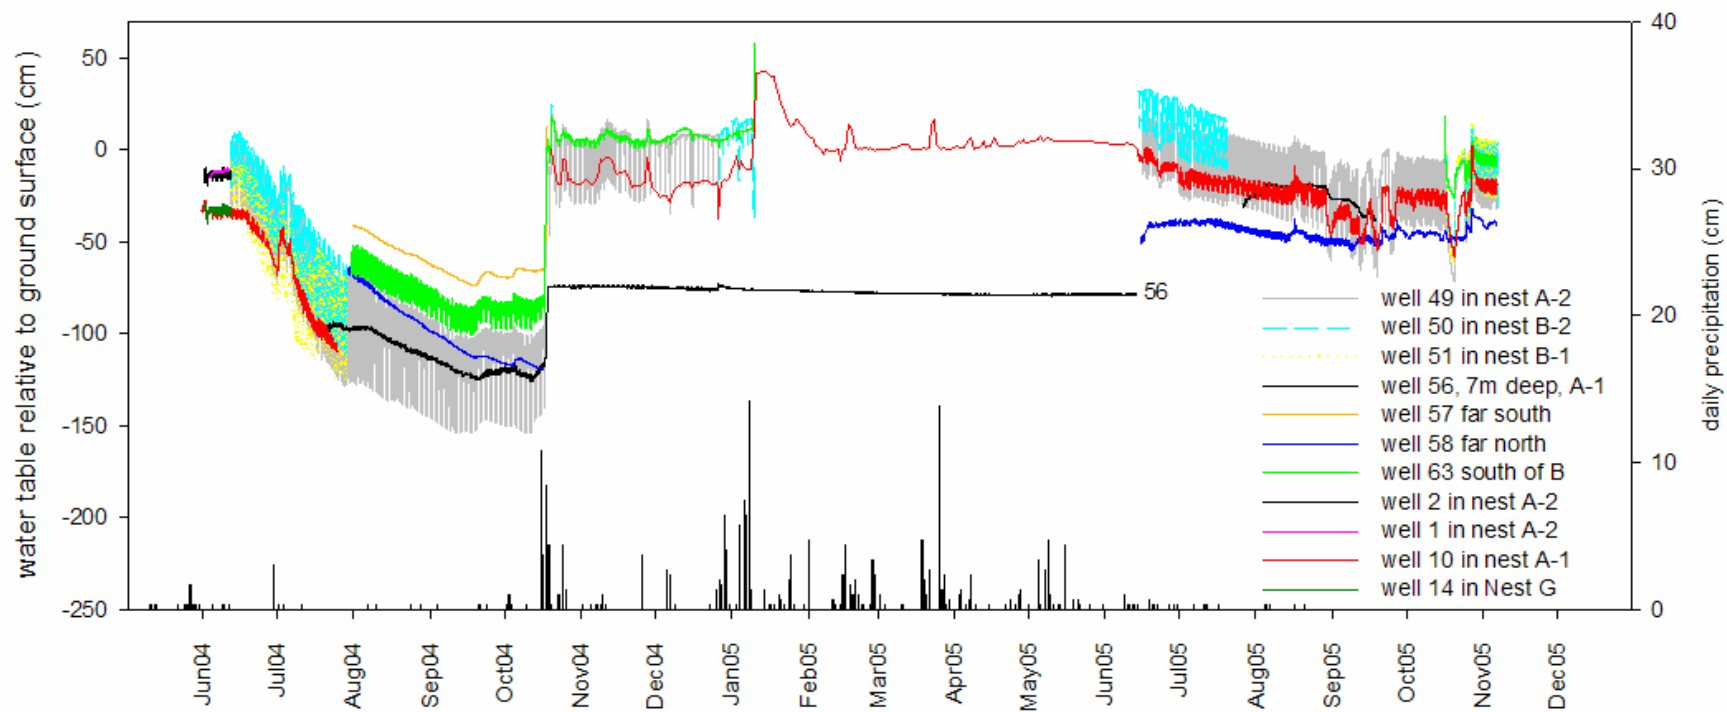
**Figure 5.** All water-level logger data (colored lines, left y-axis) and precipitation data (vertical bars, right y-axis) for Doghouse Meadow during 2004 and 2005. Gaps in water level data are due to movement of loggers to new wells, or removal for the winter.

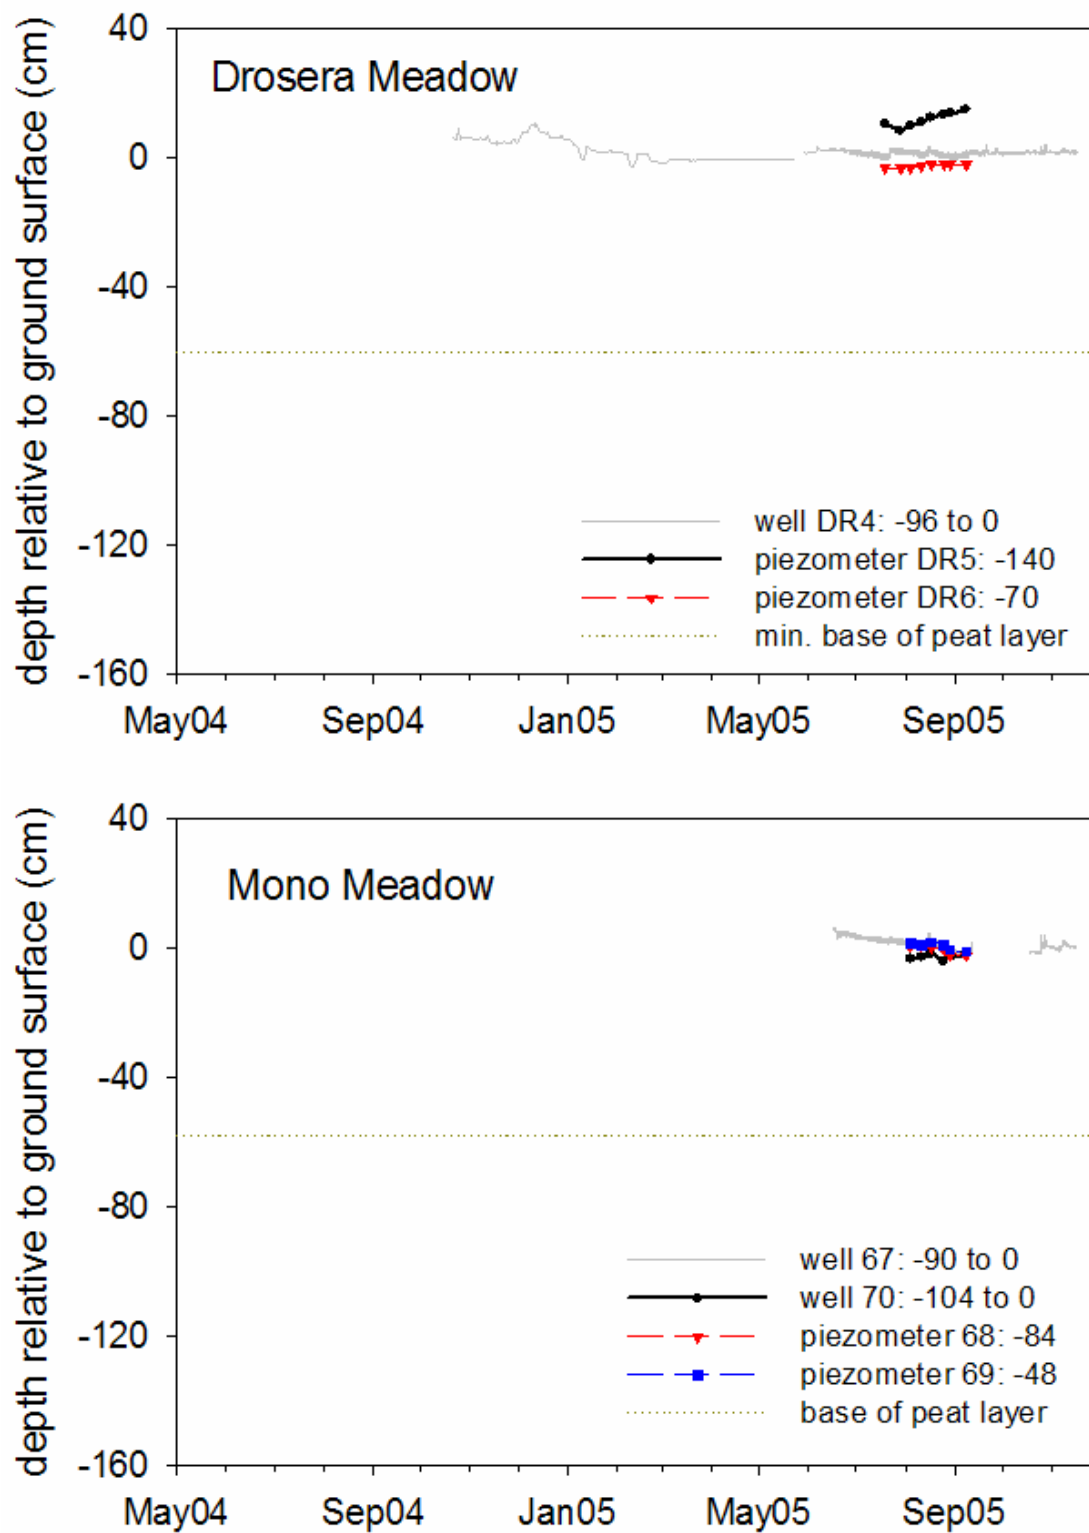
**Figure 6.** Hydrographs of the water table elevation relative the ground surface in the two reference meadows, Drosera and Mono.

reached its maximum SWE of 107.5 cm on April 12<sup>th</sup>, which was 124% of the long-term average. This difference in quantity of SWE and the later melt-out led to a large difference in ground water recharge and much greater rates of ground water flow to Doghouse Meadow through the entire summer of 2005. During the summer of 2004 the ground water table declined ~100 cm from mid-June to late-September, while in 2005 water levels declined less than 50 cm (Figure 4 and 5, Appendix B). Although the summer water table decline in Crane Flat was smaller in 2005 than in 2004, a decline occurred in all Doghouse Meadow wells. During 2005 ground water levels in Drosera and Mono Meadow remained within a few cm of the soils surface from June through late September (Figure 6).

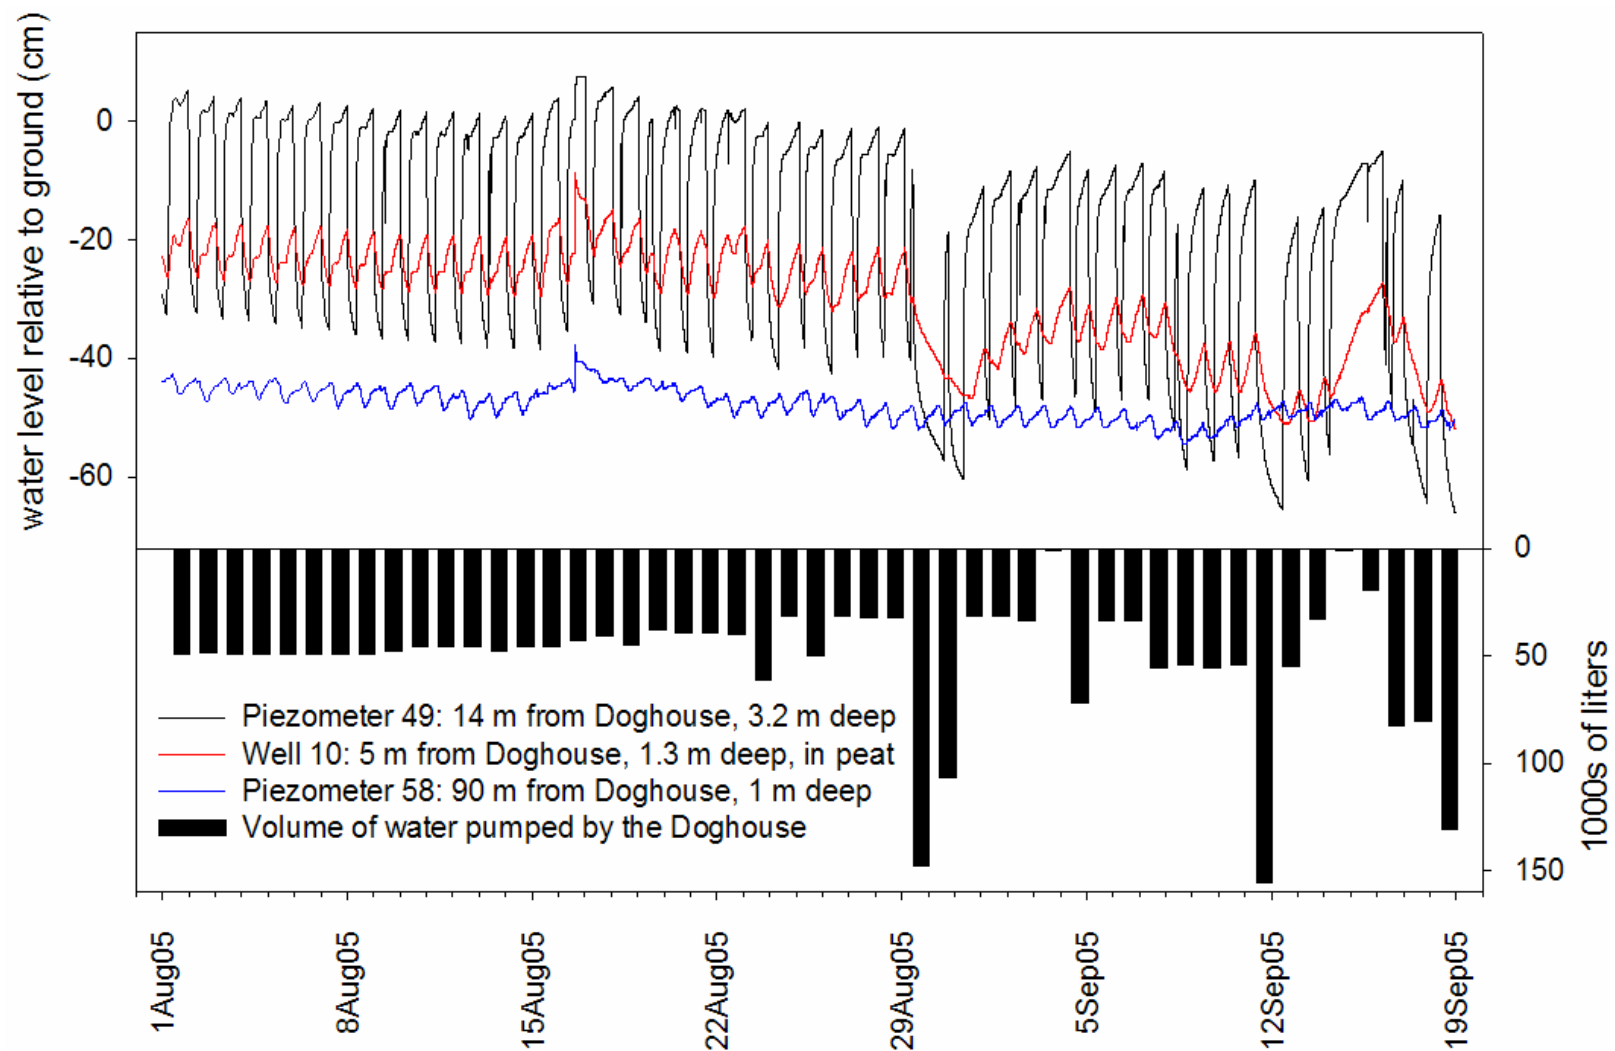
**Figure 8.** The pumping schedule for the Doghouse well (black bars) and the response of three wells (lines at top) located at different distances from the Doghouse and at various depths (see legend).

The pumping schedule from the Doghouse well reveals that nights with longer duration pumping produce deeper and more sustained water level declines than nights with shorter duration pumping. For example, long duration pumping on August 29-30, and Sept 11 produced deep draw-downs. Nights with short duration or no pumping resulted in a water level recovery, for example August 16-17 and September 14-15 (Figure 8). These effects are apparent in wells close to the Doghouse pumping well but are less detectable in wells more than 90 m away from the pumping well.

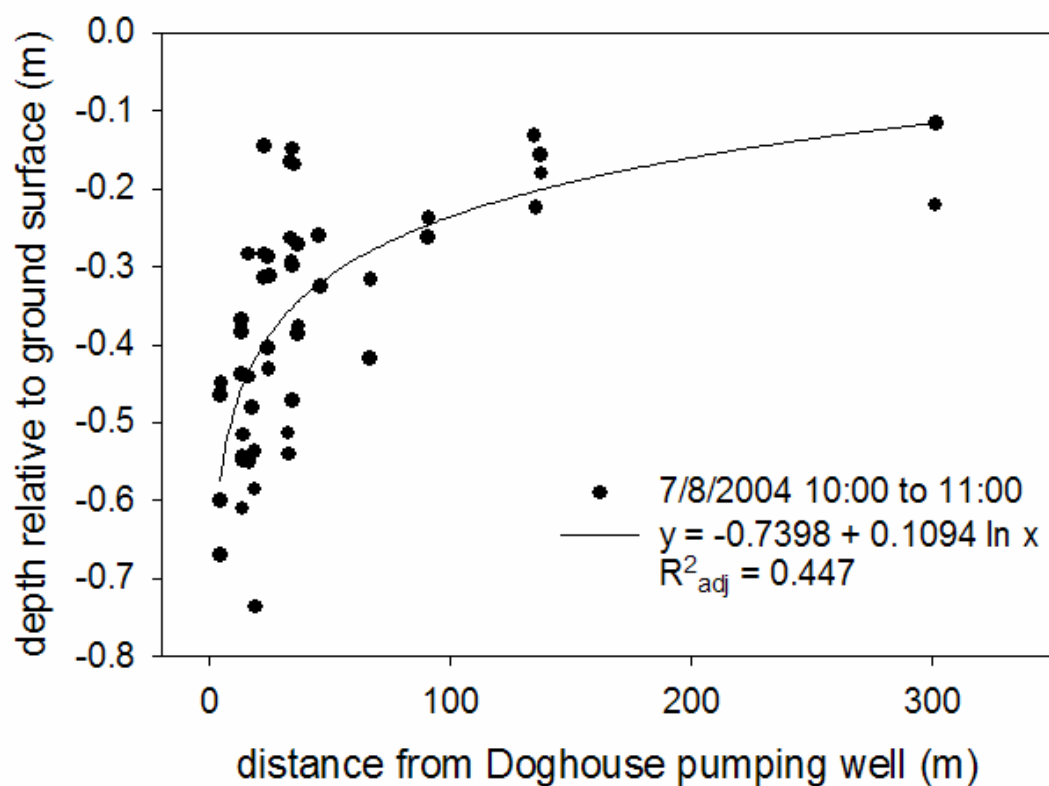
**Figure 9.** The water level of 49 hand-read wells on the morning of July 8<sup>th</sup>, 2004 as a function of distance from the Doghouse pumping well. A logarithmic function was fit to the data and the equation and correlation coefficient are shown in the legend.

A logarithmic curve fit to the water table depth on the morning of July 8<sup>th</sup>, 2004, as a function of distance from the Doghouse explained 44.7% of the variability in the data (Figure 9). Wells close to the Doghouse experience greater daily fluctuations than did wells farther away. Exponential curves fit to the daily fluctuation in water level vs. distance from the Doghouse well, explained over 96% of the variability in the data (Figure 10).

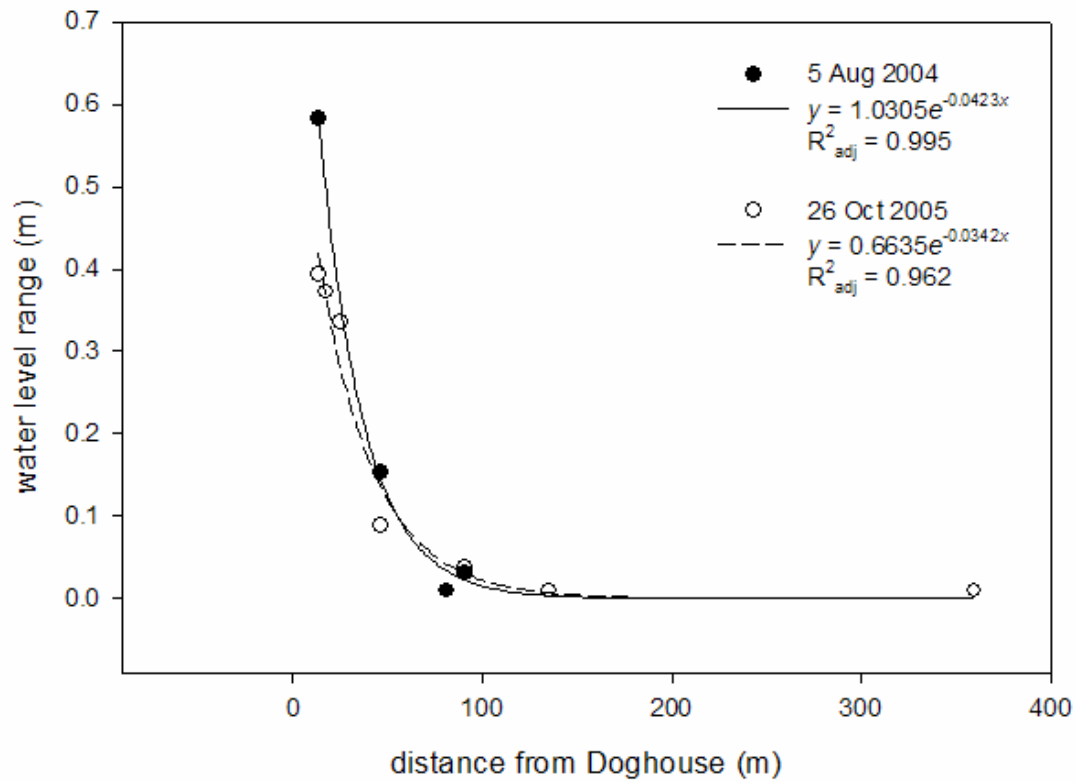
**Figure 10.** The range of daily water level in data-logged wells as a function of the distance from the Doghouse well. Each dot represents the difference between the minimum and maximum water levels in one well on the indicated day versus the distance of the well from the Doghouse. There were four wells with data loggers on 5 Aug 2004, and seven on 26 Oct 2005.

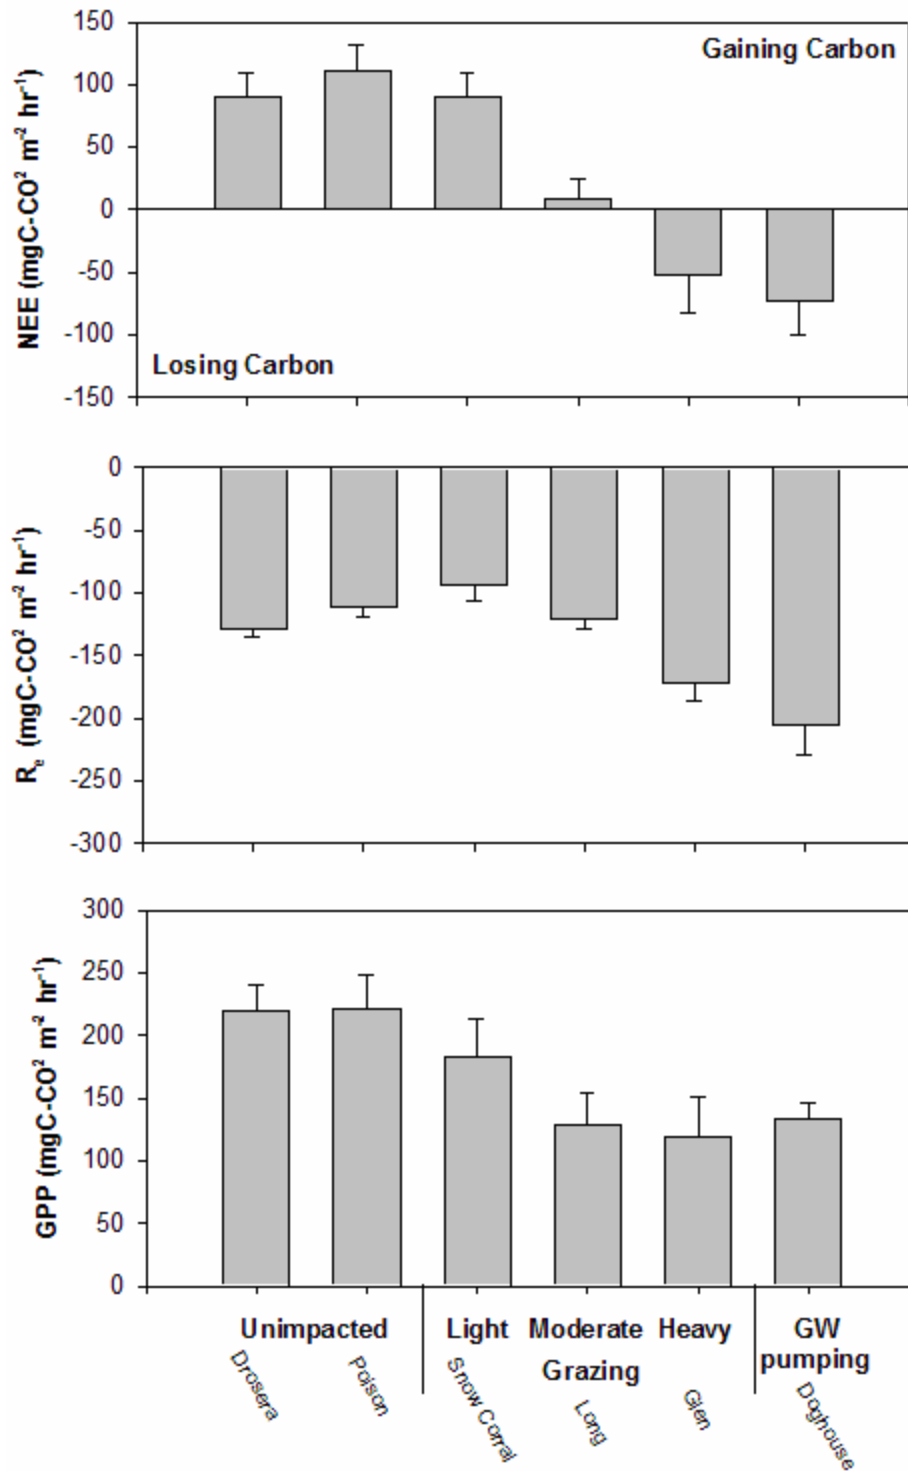
**Figure 11.** The net ecosystem exchange (NEE, top panel), which is calculated from the respiration (R, middle panel) and gross primary production (GPP, lower panel) rates measured on site, for Doghouse Meadow (far right), Drosera Meadow (far left) and several other Sierra fens in August 2004.

The carbon flux analysis indicated that the Doghouse Meadow fen has a net loss of carbon due to high decomposition rates. The gross primary production (GPP) at Doghouse Meadow is lower than at Drosera Meadow and other Sierra fens we analyzed, while the respiration (R) rate is higher. Low GPP and high R result in a negative net ecosystem exchange (NEE) rate. This means that more carbon is being released from the fen than is being stored, thus Doghouse Meadow peat body is decomposing faster than it is being formed (Figure 11). An annual carbon budget would provide more detailed information on how much C is being lost from the Doghouse fen. It is likely that much higher rates of respiration occur in the early summer as water tables are just starting to be drawn down, and yet the soils are still moist. Once the water table is drawn down, and the soils dry, respiration rates likely decline.

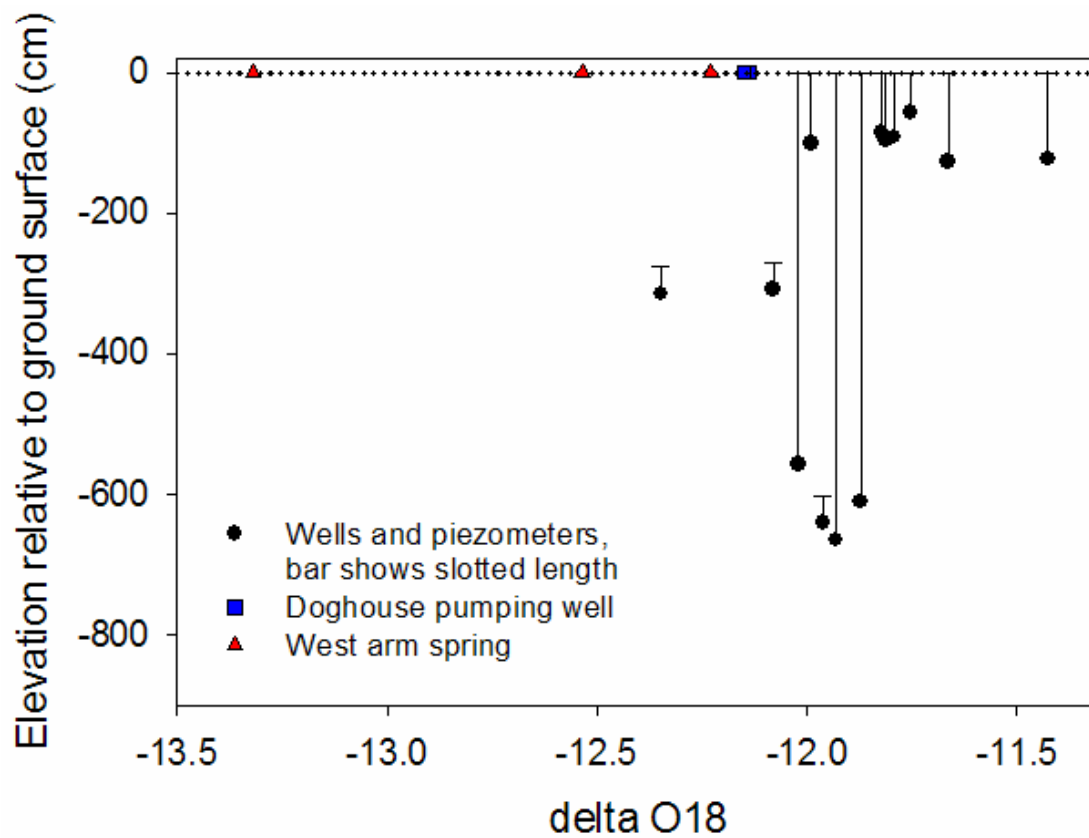
**Figure 13.** The ratio of O18 to O16 (delta O18) from different water sources at different depths for 2004. The less negative delta O18 values (to the right) are enriched in the heavier isotope, probably via evaporation of the lighter isotope.

Our stable oxygen isotope data (Figure 13) indicates that piezometer water is slightly more depleted in  $\delta^{18}\text{O}$  (more negative values) than water from monitoring wells within the peat body. This difference may be due to evaporative enrichment of water in the peat body. However the differences in isotopic signature between piezometer water, and monitoring water are very small and do not indicate multiple water sources. The groundwater emerging from the west arm spring complex have the most negative  $\delta^{18}\text{O}$  values, indicating that it has not undergone evaporative fractionation (resulting in more enriched or more positive values), nor mixed with other waters. The isotopic signature of the pumping well water is intermediate between that of the west arm springs and the meadow groundwater, suggesting that the Doghouse well water is a mixture of the two sources.

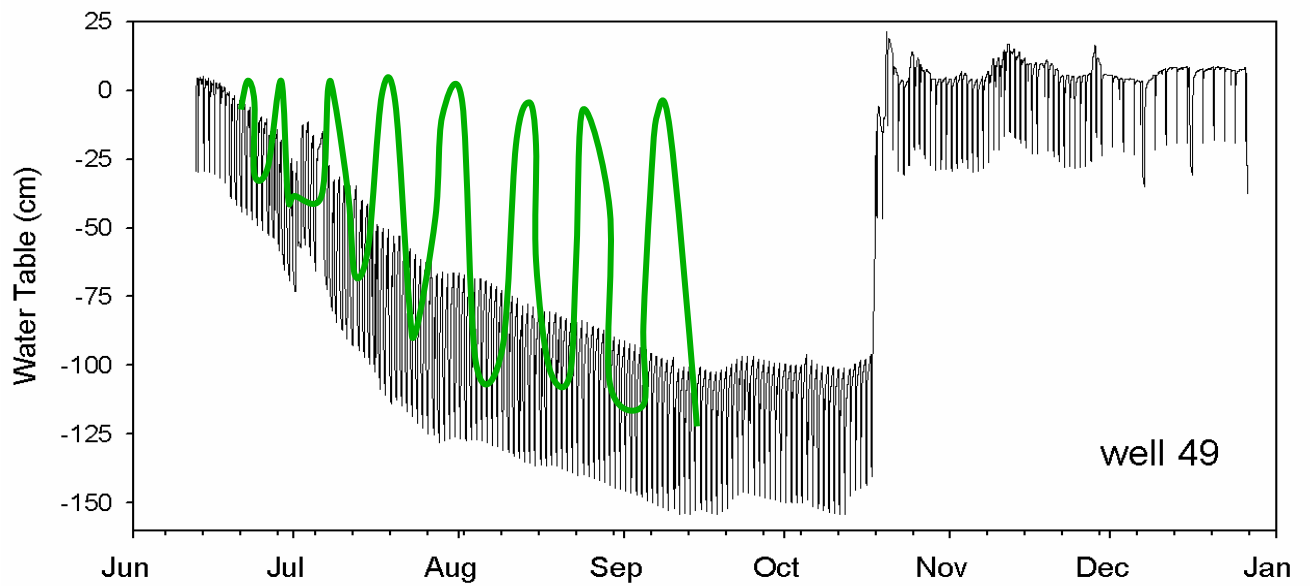
**Figure 17.** Suggested pumping scenario for a dry summer is shown in green line, while the pumping scenario from 2004 is shown in black.

Option 3 above may provide a management alternative where a modified pumping schedule, combined with larger storage capacity could provide for human and meadow water needs. As shown in Figure 17, if water could be pumped for a longer period of time, such as several days in a row, the water table could be drawn down. When water storage tanks are filled, the pumps could be turned off for a period that would allow the water table to recover to the soil surface, and re-saturate soils. If the soils had sufficient water retention time, the saturation may retard organic matter decomposition processes. A pumping scenario, shown in Figure 17, could be used between mid-June and mid-September on most years. There would have to be considerable experimentation with this pumping scenario, and the duration of drawdown would vary by water year, with more pumping being possible in summers following larger snow years. This approach would need a strong monitoring component. If the soils alternatively wetted and dried, soil respiration rates might be higher than they would be if the soils were dried once. Also, the wetting and drying could lead to higher nitrogen mineralization rates, producing a fertilizer effect, and further increasing decomposition rates. These effects could be measured with a careful monitoring program that measured water levels, carbon gas flux, and nutrient availability. Because of the ongoing need to provide water for domestic use, we recommend option 3, with experimentation on pumping rates and duration, and rest duration that will allow the water level to recover. In addition, monitoring is essential to understand whether this produces a fertilizer effect, and produced the desired hydrologic effect of maintaining saturated soils in the upper soil horizons, and eliminates habitat for pocket gophers and voles.
