Snake River Gravel Pit, Grand Teton National Park and John D. Rockefeller National Parkway: Injury Assessment Due to the Introduction of *Carex feta* Bailey and Restoration

David J. Cooper, Ph.D., Department of Forest, Rangeland and Watershed Stewardship, Colorado State University, Fort Collins, CO 80523

National Park Service, John D. Rockefeller Jr. Memorial Parkway
and Grand Teton National Park

March 2007

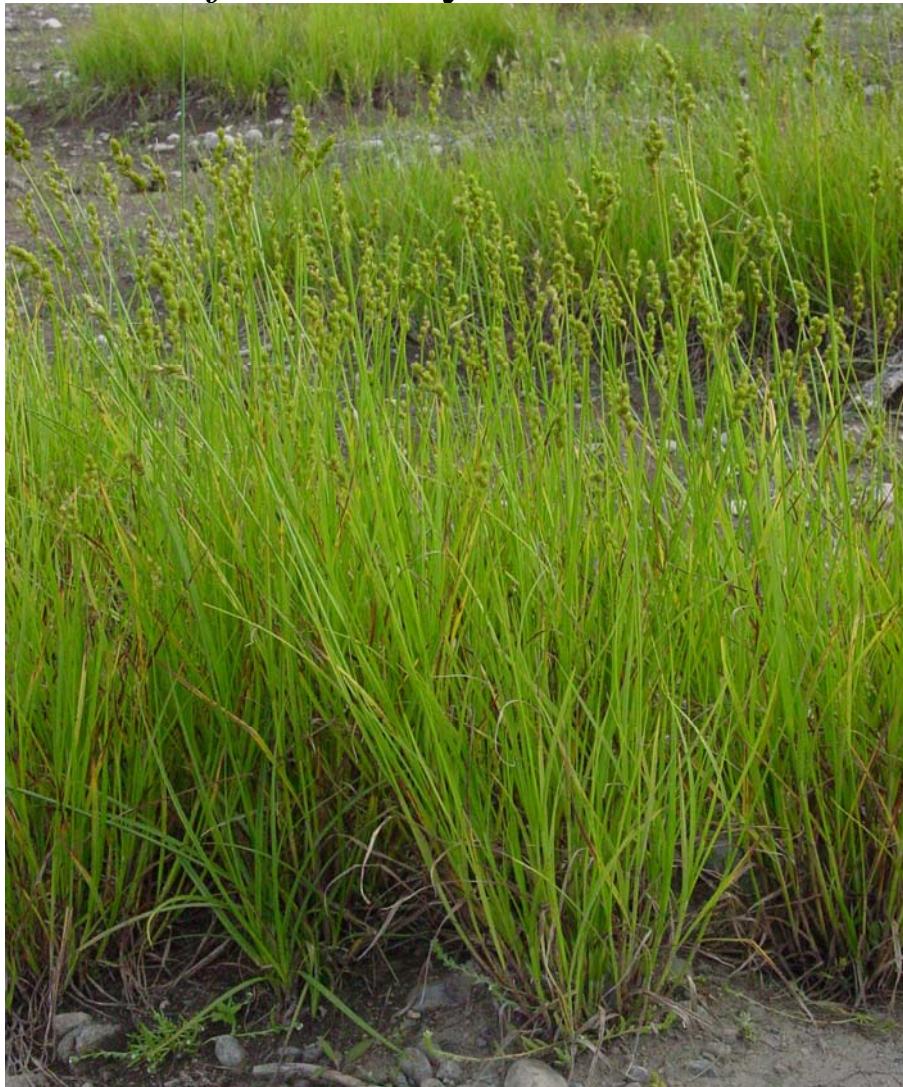
was possible in 2004 (see cover photo from 2004), a soil seed bank was produced during 2004, which likely included tens of millions of seeds.

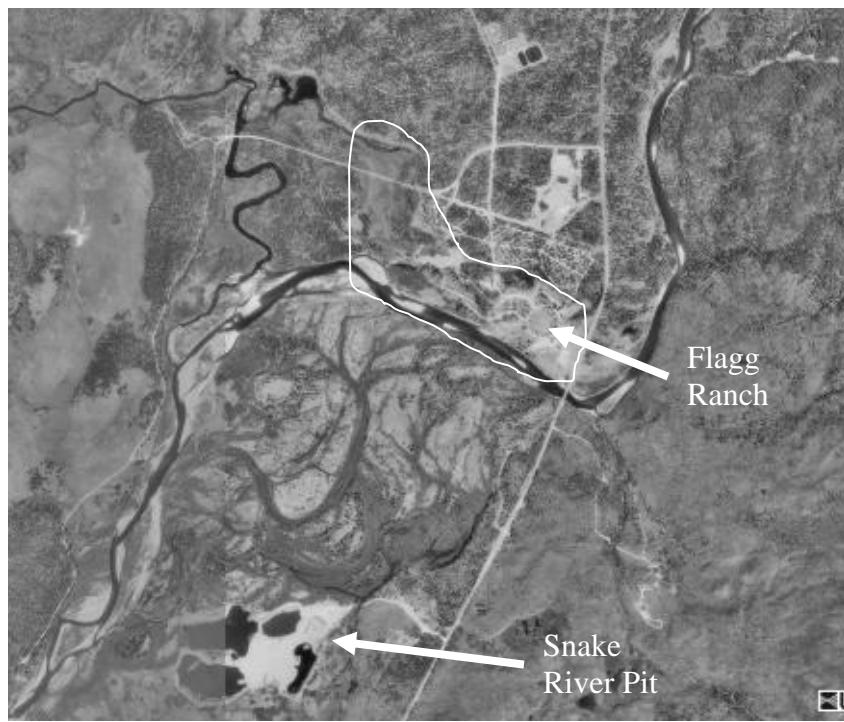
Figure 1. Locations of Snake River gravel pit and Flagg Ranch are shown in the black and white air photograph. The Snake River flows through the photo from top right to lower left. The highway running north to south is US 191/287.

Both wetland and upland compensatory restoration project(s) will be at the former (abandoned) Flagg Ranch site adjacent to the Snake River. This site is located ~2 km north of the Snake River Gravel Pit (Figure 1) and historically contained floodplain wetland ecosystems similar to those at the gravel pit site, and uplands similar to those occurring near the gravel pit. The goal of the compensatory restoration is to remove human placed fill, restore the pre-disturbance hydrologic regime, and plant sites with suitable native plant species to restore the vegetation and wetland characteristics.

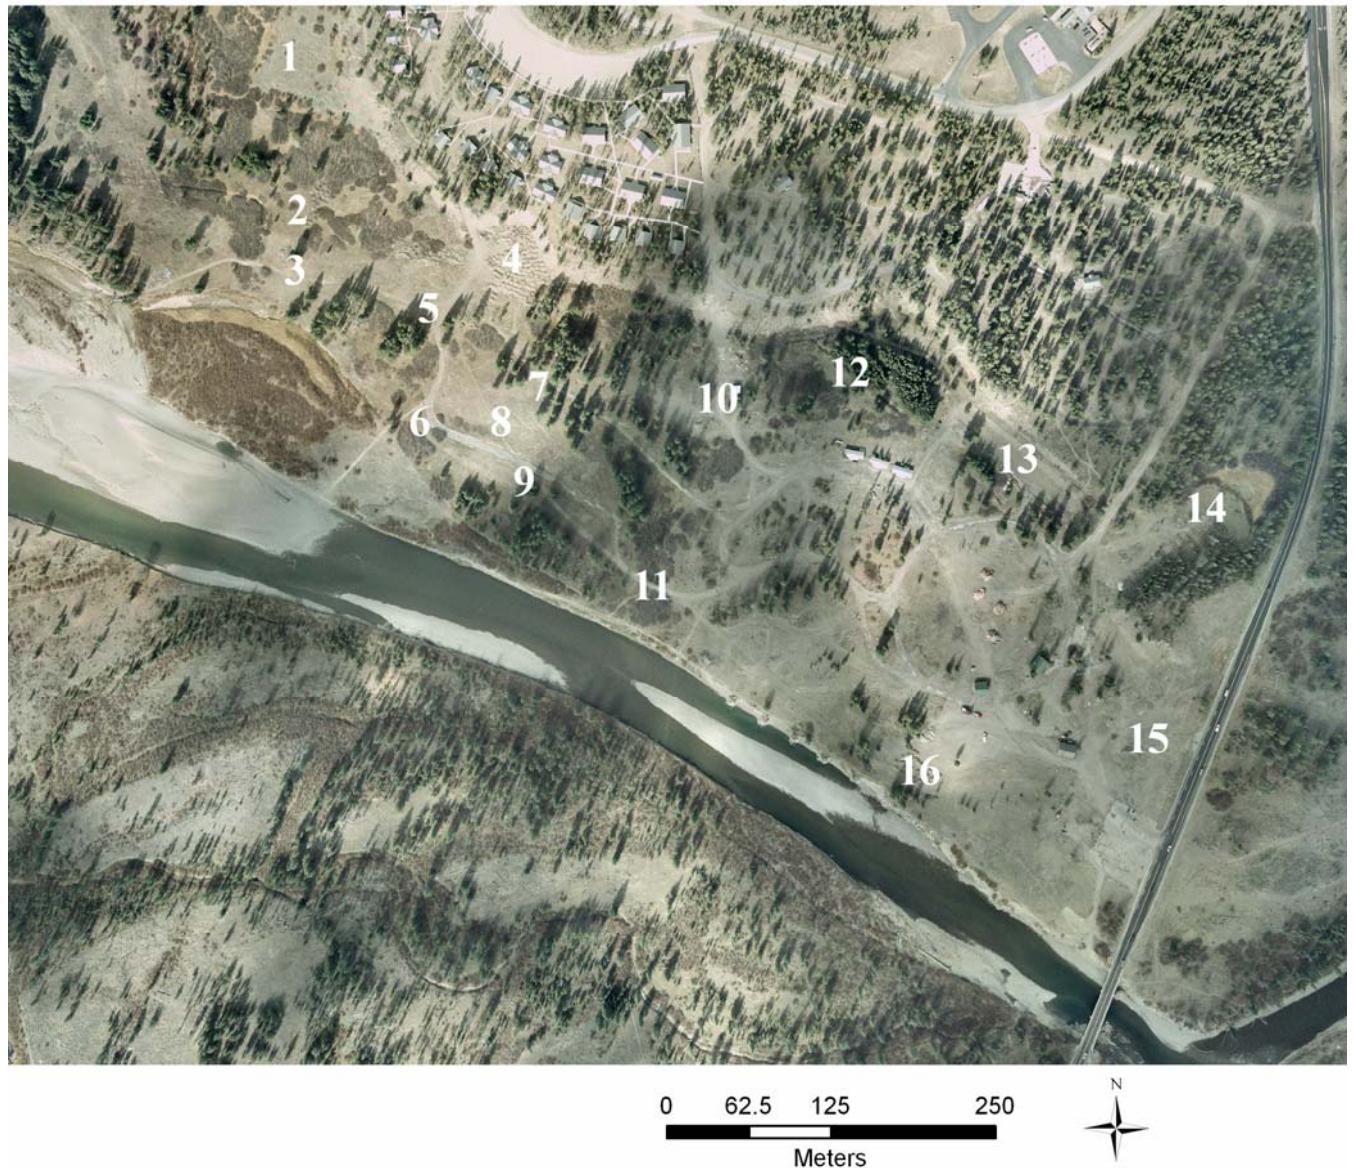
Figure 2. Location of the 16 project sites overlain on a high quality air photograph.

Disturbances to the Flagg Ranch site include filling, vegetation removal, and ground disturbance. We have identified 16 areas that were disturbed and where restoration could occur. Some projects are for wetlands and others for uplands. Each is identified in Figures 2 and 3, and discussed here. In Table 1 I identify the restoration area, fill thickness and fill volume.

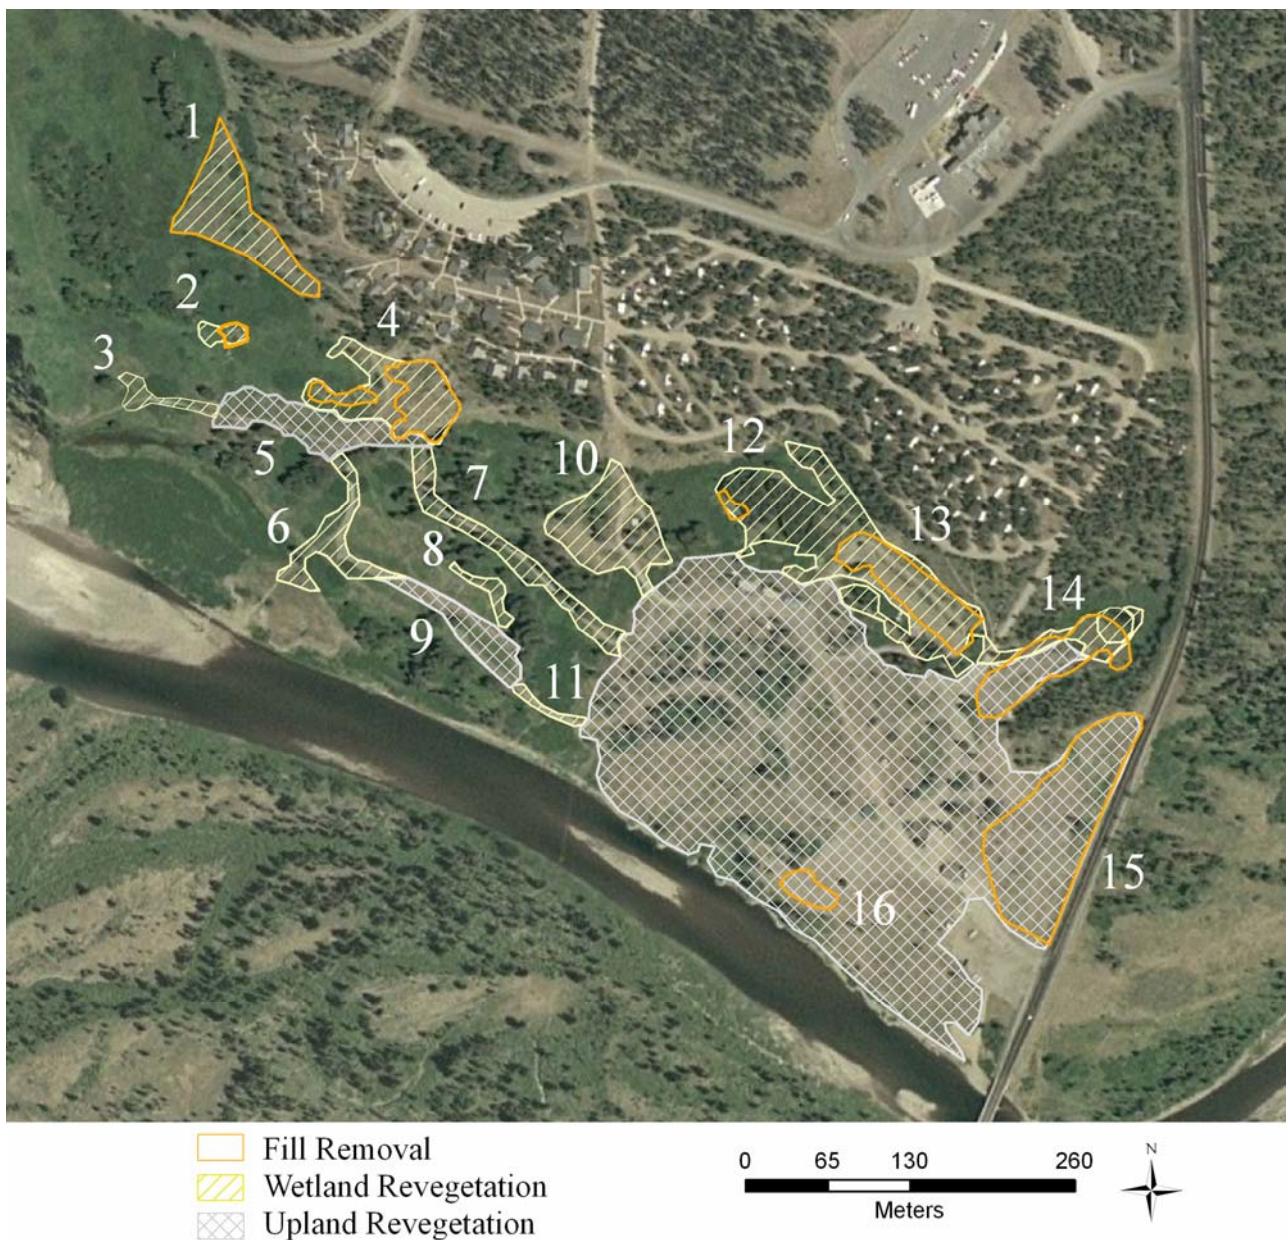
Figure 3. Location of the 16 proposed restoration projects, and identification of whether they include fill removal, and whether they are upland or wetland projects.

The 16 restoration sites were prioritized by GRTE staff. The order presented below reflects projects that they felt could potentially provide good habitat value. The location of each site is shown in Figures 2 and 3, and the area and amount of fill are presented in Table 1. Each site and the proposed restoration project is described above. Each project is more fully described in Cooper and Patterson (2007).
