# **HISTORIC STRUCTURE REPORT**

## **RANGER CABIN & BOUNDARY FENCE**

### **WALNUT CANYON NATIONAL MONUMENT**

March 2007

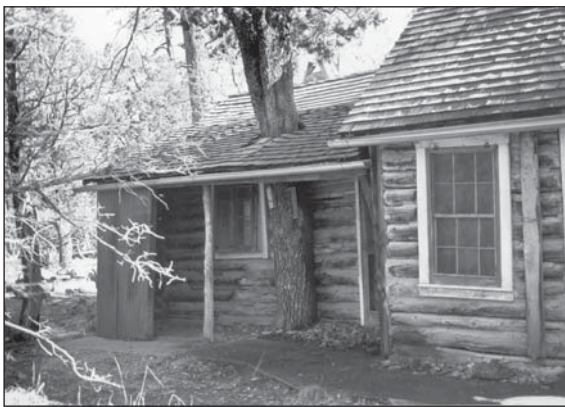
Fig. 12: Ranger Cabin with corrugated sheet metal at kitchen porch corner and exterior bracing, April 1988 (WACA 2373)

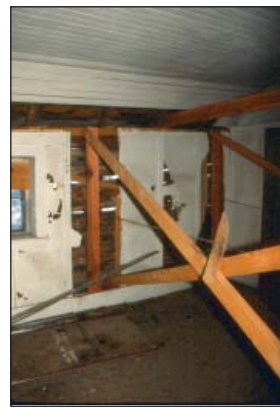
Fig. 13: Interior bracing of the Ranger Cabin, May 1990 (WACA 2373)

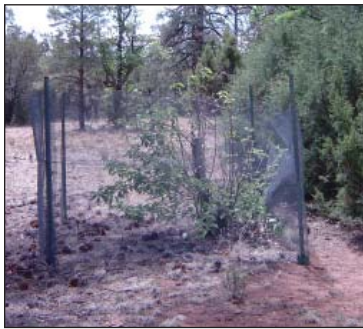
Site Deficiency	Recommended Treatment*	Impact
Chicken wire fence around apple tree. (Fig. 23)	Remove chicken wire fence and replace with fence appropriate to character of site.	Low
Trees in contact with building.	Cut branches in contact with building and thin trees in close proximity to building.	Severe
Outhouse structurally unsound and door removed. (Fig. 25)	Stabilize outhouse and install door.	Severe
Concrete basin of birdbath cracked.	Remove concrete basin and repour concrete in place, matching historic condition.	Moderate
Birdbath stones displaced. (Fig. 26)	Install stones.	Moderate
Retaining wall stones displaced.	Install stones.	Moderate
Walkway planks warped. (Fig. 28)	Remove plank walkway. Replace with concrete, matching historic condition to alleviate future maintenance concerns.	Moderate

Fig. 23: Apple tree in front of the Ranger Cabin, 2006.

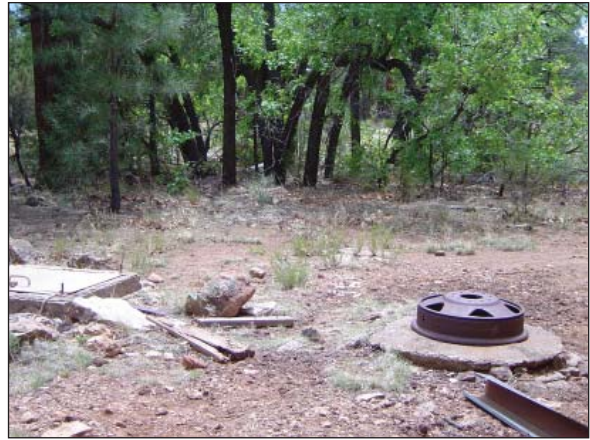
Drainage Deficiency	Recommended Treatment*	Impact
Gutters fail to move water away from the building. (Figs. 39, 40, 41)	Repair gutters where possible. Replace gutters where damaged beyond repair. Raise gutters to proper height. Install additional downspout on each elevation. Install perimeter drain system.	Severe
Tree flashing is pulled upwards and allows moisture penetration to roof. (Fig. 42)	Remove flashing. Install new flashing of proper size.	Severe
No flashing present at eaves.	Install flashing at eaves.	Severe
Ground slopes toward building.	Regrade site to slope away from building.	Severe
* Note: Please see <i>Requirements for Treatment</i> for additional information on each recommendation.

Fig. 40: Cement-capped cistern with locked hatch at left and water catchment at right, 2006.

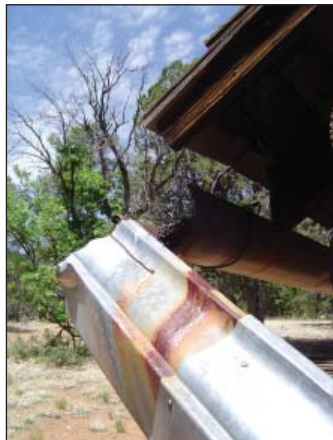
Fig. 41: Blocked gutter at southeast corner, 2006.

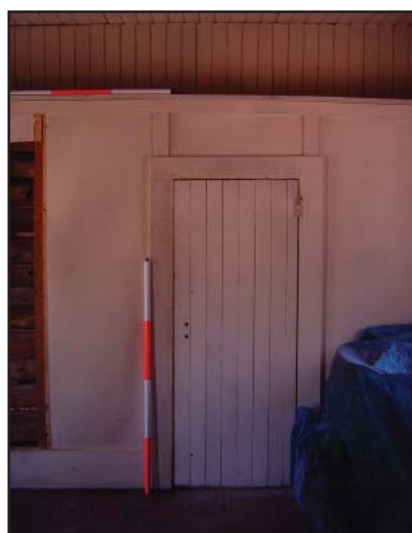
Fig. 46: East wall of Room One showing recess and shelf above original exterior wall, and irregular height beadboard door, 2006.

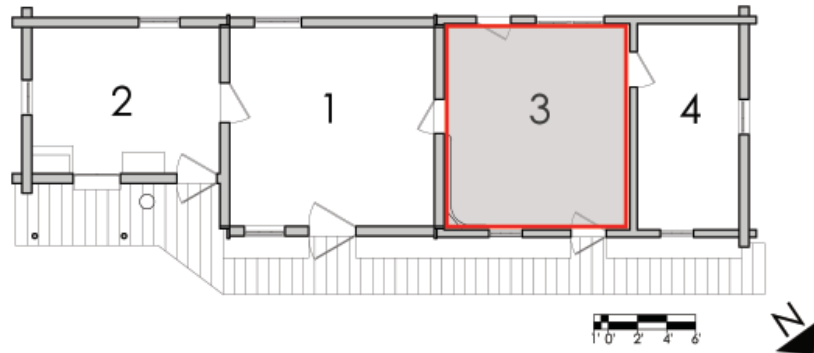
Fig. 52: Reference floor plan showing location of Room Three.

Room Three, the first room of the last addition, is in better condition than any other room of the Ranger Cabin.

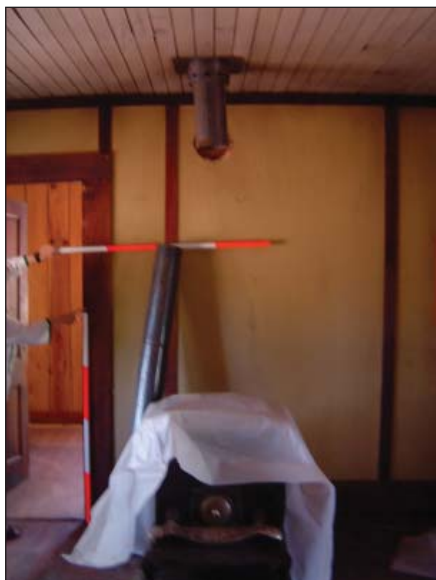
Room Three Deficiency	Recommended Treatment*	Impact
Ceiling damaged around stove pipe. (Fig. 54)	Seal opening. Replace with matching beadboard around stove pipe. Paint to match.	Severe
Ceiling beadboard missing at north and south walls, and damaged in ceiling center. (Fig. 53, 55)	Install matching beadboard where missing. Paint to match.	Severe
Wallboard damaged or missing near windows on north and south walls. (Fig. 53)	Remove damaged wallboard. Insulate. Install similarly-textured and painted drywall where missing. Paint to match. Install battens to match existing battens. Paint battens to match.	Moderate
Hole in wall above stove.	Remove damaged wallboard. Insulate. Install similarly-textured and painted drywall.	Moderate
Wallboard stained around telephone mount. (Fig. 55)	Maintain discoloration for interpretive purposes.	Low
Doors and windows askew.	Stabilize building and remove exterior walls where problematic. Insulate. Attach logs to hog-trough corners with rebar reinforcement, and if necessary, wood splices. Square doors and windows.	Severe

Fig. 54: West wall of Room Three showing stove pipe, wallboard, and stove, 2006.

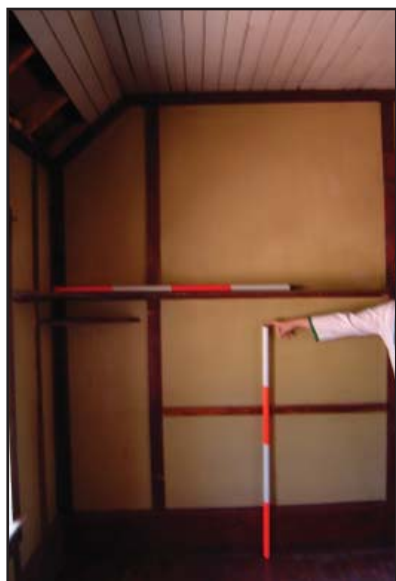
Two darkly stained wood display shelves remain in the eastern corner of this room, which once functioned as the monument's museum. The original stove remains in this room; a stove component is cataloged in the museum collection and stored in that facility.

Fig. 56: East wall of Room Three showing wall trim and corner display shelves, 2006.

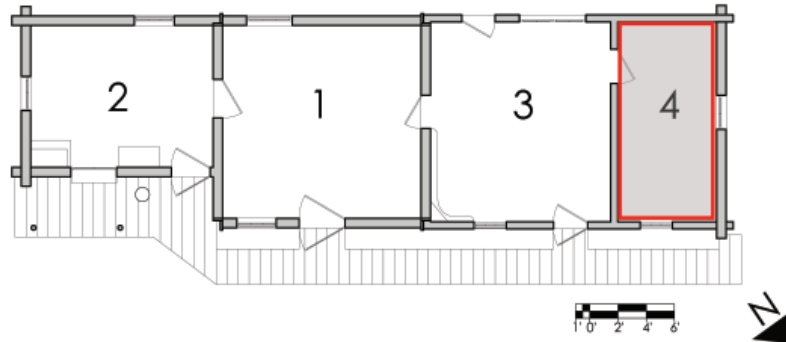
Fig. 58: Reference floor plan showing location of Room Four.

The truncated ceiling of Room Four mimics the other rooms, with white-painted beadboard. Some ceiling beadboard is missing. Square and round holes at the east end were likely cut for exhaust of the stove in Room Three.

The room has exposed vertical wall members, with evidence that they were once covered with wallpaper over burlap. Burlap and wallpaper remain in small quantities directly over the vertical wall members. The east wall is damaged below the ceiling exhaust hole.

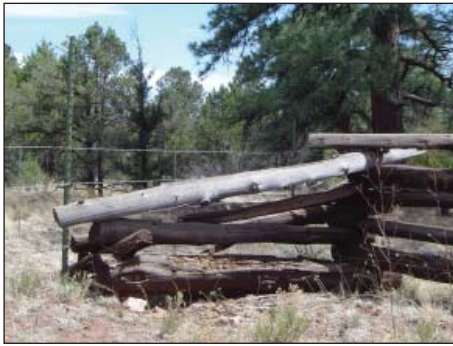
Fig. 4: Eastern termination of Boundary Fence, 2006.

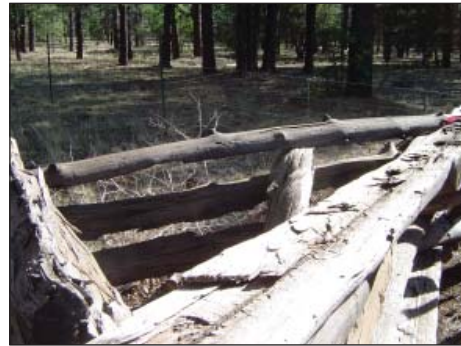
Fig. 5: Western termination of Boundary Fence, 2006.

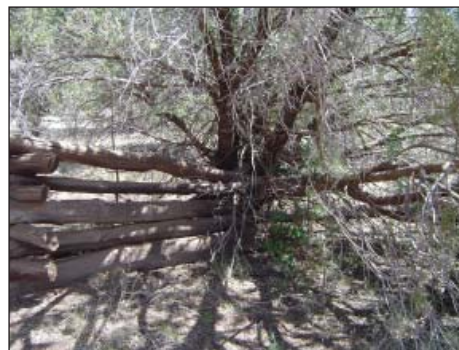
Fig. 10: Intersection of Boundary Fence and tree, 2006.
