**Bury Hall Renovation  
NAU Project #09.080.241  
October 20, 2023**

**ADDENDUM #1**

**ATTACHMENT E – FACILITY CONDITION ASSESSMENT FOR BURY HALL**

## Facility Condition Assessment

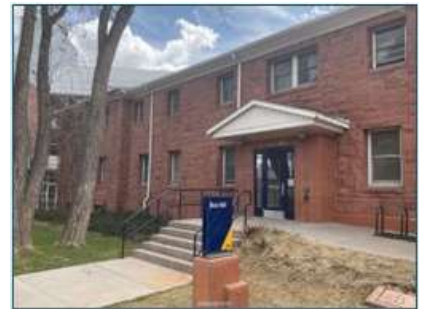
#### 8 - Bury

Bury is located at 610 Knoles Dr, Flagstaff, AZ 86011. The building was originally constructed in 1908, with a floor area of 17,470 SF.

Bury received its most recent renovations between 2013-2015, with the installation of the DDC automation/monitoring controls and the updating of the fire alarm system. Bury serves primarily as office space and is heated using steam provided by the North Heating and Cooling Plant.

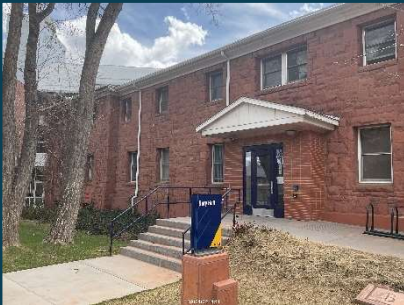
### 8 - BURY

BUILDING TYPE:	Office
YEARS BUILT:	1908
GROSS SQUARE FOOTAGE:	17,470
DATE ASSESSED:	4/1/2022
OVERALL PRIORITY SCORE:	14.1

SUBSYSTEM	DESCRIPTION	PRIORITY SCORE
A10 - Foundations	The foundation is assumed to be original to 1908 construction, and will likely need further inspection and refurbishment as soon as feasible due to its age.	18.0
B20 - Exterior Enclosure	The exterior enclosure consists of stone masonry walls, which are in average to somewhat poor condition. Some minor grout deterioration and stone erosion was noted. The exterior metal and wood doors are in poor condition, replacement needed as soon as feasible. The exterior vinyl windows appear to have been replaced circa 2000, and will likely require replacement within 8 years.	13.0
B30 - Roofing	The roofing appears in average condition, the year of last replacement is not known. Approximate remaining life is 6-10 years.	13.0
C10 - Interior Construction	The interior drywall walls appear original. Portions of water damage to drywall were noted near the exterior wall interface, especially for below grade walls. Interior wood and metal doors appear in fair condition.	13.8

C20 - Stairs	Interior stairwells appear to be in somewhat poor condition. The traction surfaces covering the stairs will likely need replacement within 4 years.	14.0
C30 - Interior Finishes	The interior flooring is outdated, high traffic portions of carpeting and VCT flooring have a remaining life of 3-5 years.	13.6
D20 - Plumbing	The domestic water softener has failed, and needs replacement as soon as possible. Water supply and wastewater piping are likely outdated and may require further investigation and potential refurbishment within 7 years.	11.9
D30 - HVAC	The heating water generation system was abandoned, and converted to a steam system for the radiators. Generally, the HVAC equipment have either been abandoned or are in poor condition. Replacement of the buildings heating system and equipment is recommended within 3 years.	13.1
D40 - Fire Protection	The fire suppression system appears to have been last updated in 1982, and is now due for updates and equipment replacements.	17.0

D50 - Electrical	The majority of the electrical distribution equipment was replaced circa 2001. Interior and exterior lighting appear dated, and include both fluorescent and incandescent lamps. Replacing these fixtures with LED is recommended to reduce energy costs. The fire alarm system was last updated circa 2015.	15.0
