# Northern Arizona University – Education & Support Facilities

## Facility Condition Assessment

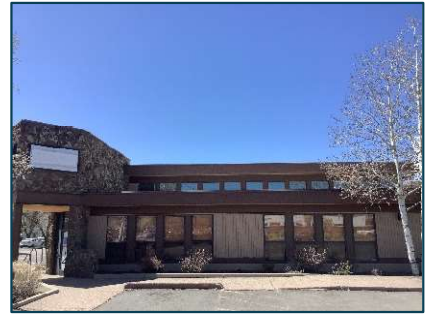
#### 7C - Butler Office Building

Butler Office Building was recently acquired by NAU and is currently unoccupied. The building previously served as a branch bank. There have been no recent renovations under NAU ownership. Heating and cooling are provided through standalone unitary heating and cooling units.

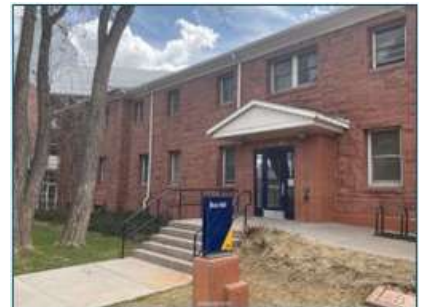
#### 8 - Bury

Bury received its most recent renovations between 2013-2015, with the installation of the DDC automation/monitoring controls and the updating of the fire alarm system. Bury serves primarily as office space and is heated using steam provided by the North Heating and Cooling Plant.

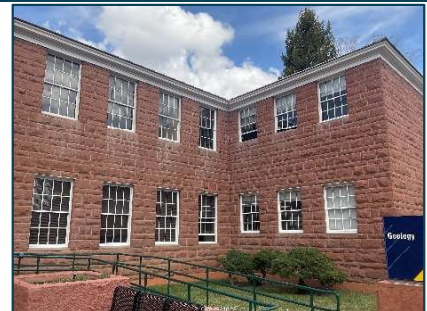
#### 12 - Geology

The Geology building has undergone multiple minor renovations over the last 10 years, including installing DDC controls and meters (Noresco), updating the interior finishes, and HVAC/plumbing equipment replacements. The Geology building is used primarily for classroom and office space and is provided steam from the North Heating and Cooling Plant.

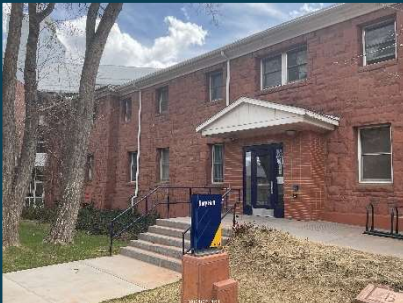
### 8 - BURY

| SUBSYSTEM | DESCRIPTION | PRIORITY SCORE |
|---|---|---|
| A10 - Foundations | The foundation is assumed to be original to 1908 construction, and will likely need further inspection and refurbishment as soon as feasible due to its age. | 18.0 |
| B20 - Exterior Enclosure | The exterior enclosure consists of stone masonry walls, which are in average to somewhat poor condition. Some minor grout deterioration and stone erosion was noted. The exterior metal and wood doors are in poor condition, replacement needed as soon as feasible. The exterior vinyl windows appear to have been replaced circa 2000, and will likely require replacement within 8 years. | 13.0 |
| B30 - Roofing | The roofing appears in average condition, the year of last replacement is not known. Approximate remaining life is 6-10 years. | 13.0 |
| C10 - Interior Construction | The interior drywall walls appear original. Portions of water damage to drywall were noted near the exterior wall interface, especially for below grade walls. Interior wood and metal doors appear in fair condition. | 13.8 |
| C20 - Stairs | Interior stairwells appear to be in somewhat poor condition. The traction surfaces covering the stairs will likely need replacement within 4 years. | 14.0 |
| D20 - Plumbing | The domestic water softener has failed, and needs replacement as soon as possible. Water supply and wastewater piping are likely outdated and may require further investigation and potential refurbishment within 7 years. | 11.9 |
